Report on Spurwing Dam, Letata, Dullstroom

Cutwater Farms (Pty) Ltd

Prepared by Nicholas Papenfus

April 2004

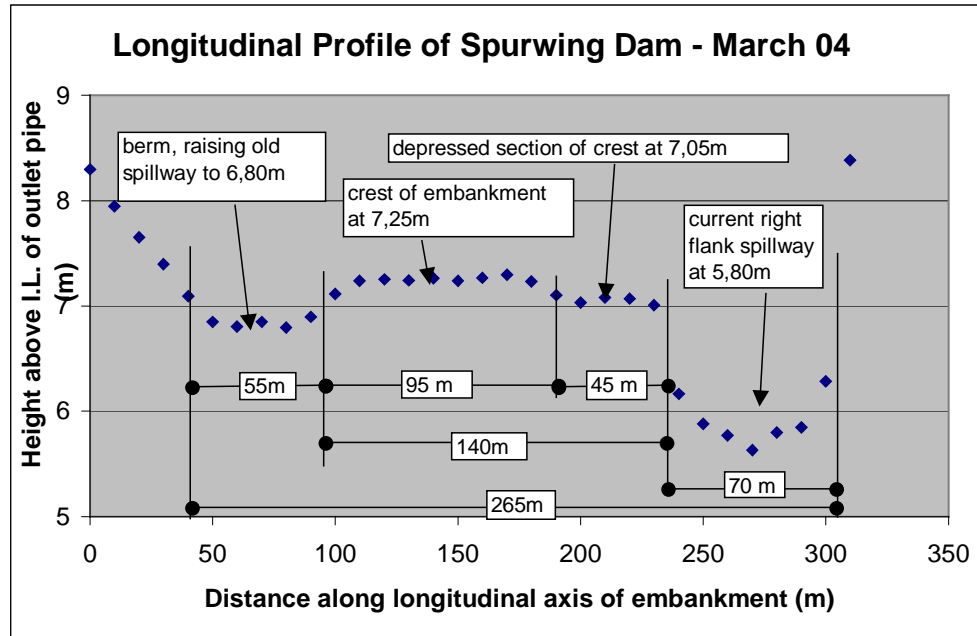
Figure 1 – Longitudinal Profile of Spurwing Dam. All levels are referenced to the invert level of the outlet valve, and are spaced 10m apart. The current right flank spillway has on average an elevation of 5,8m, while the left flank spillway begins to function when the water rises to a height of 6,8m, as this is the elevation of the crest of the road/berm that now traverses it. The crest of the embankment between the two spillways is at an elevation of approximately 7,25m, except for a 45m stretch on the right which is about 0,2 m lower.

- Depth of Spurwing dam - Figure 1 shows that the right flank spillway is on average 5,8m above the outlet valve's invert level, which in turn is estimated at 0,6m above the riverbed. Thus the elevation of the water at FSL (the level at which water starts running down the spillway) relative to the riverbed is $5.8 + 0.6 = 6.4\text{m}$.
- Impoundment volume of Spurwing dam – Owing to the onset of darkness and a storm, there was insufficient time to accurately assess the capacity of the reservoir. However based on the many photographs that were taken earlier, the dimensions given in figure 1, and visual estimates of distances, surface area and topography, it appears that the capacity of the reservoir at FSL may be slightly less than 50000m³.

It is evident from figure 1 that the crest of the embankment is virtually horizontal. This is generally an indication of an embankment that was well compacted during the construction stage. All embankment dams consolidate (compact under their own weight with time) to a greater or lesser extent, and clearly consolidation will be greater where the embankment is highest. So for an embankment to still be virtually horizontal and not V shaped after 12 years implies that it was very well compacted at the construction stage. A well compacted embankment generally has good shear strength and hence the various forms of shear failure that are possible are most unlikely even for the increased forces associated with a possible overtopping event (to be discussed later). It also means that it will not erode as easily as would a poorly compacted embankment in the event of water flowing over the crest and down the embankment during overtopping.

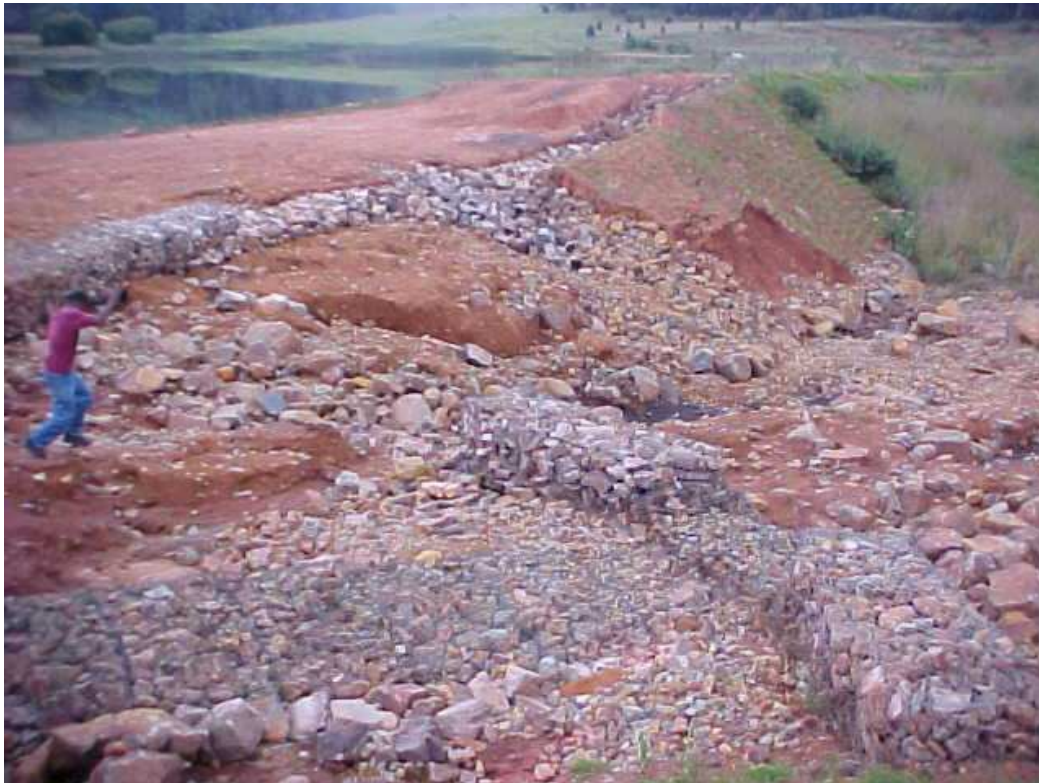
- 5.5 In the foreground of figure 2 a small gabion structure may be seen, and there are a number of these structures immediately upstream of the one in view.

Presumably they were intended to keep the residual flow of the river away from the toe of the embankment. However, they are too insignificant to cope with flows generated by heavy rainfall in the catchment, let alone flood events. Therefore the proposed design calls for a series of weirs of a much sturdier configuration that span the full width of the 51m channel, creating steps that lower the water up to 2m at a time (see figure 4). The gabion cages and rocks that have been used in these structures can be reused to construct the new structures.

Figure 2 – This picture illustrates how several of the requirements for a spillway have been overlooked. The spillway is far too steep (see requirement 4.3.4) and consequently significant erosion is evident. It is also evident that the water that flows over the left side of the spillway discharges its water directly down the embankment (see requirement 4.3.3). The crossflow in the spillway channel (see requirement 4.3.7) results in water flowing against the toe of the embankment, and this has resulted in erosion for a considerable distance.

As indicated in figure 2 and 3 the effected areas are not large, and the repairs can thus be effected relatively easily with simple compaction equipment.

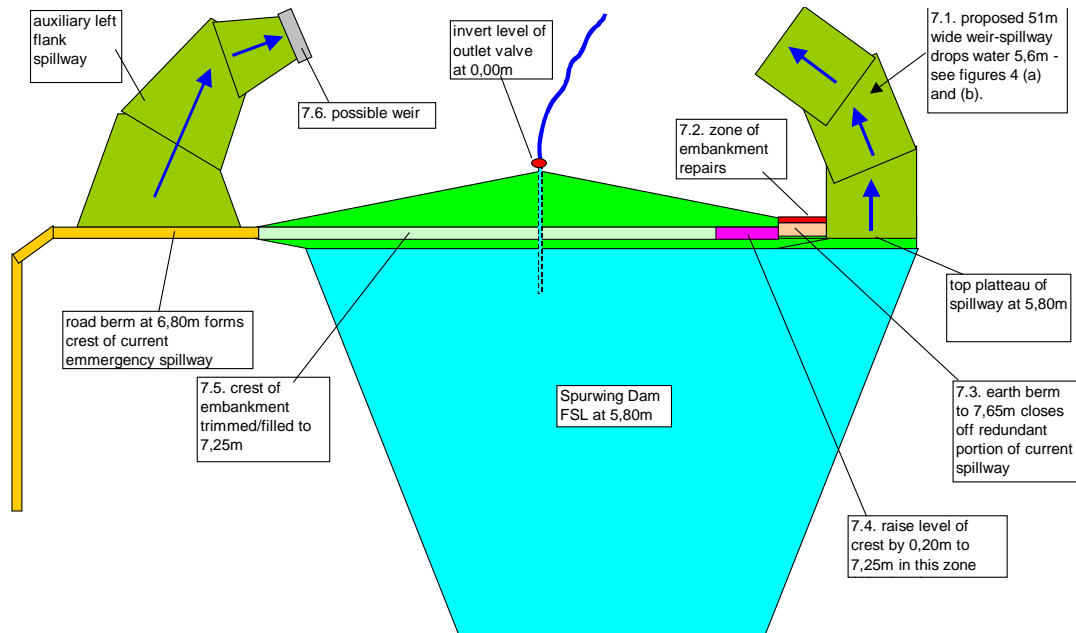
Figure 3 – Schematic Plan of Spurwing Dam indicating proposed scheme of work (7.1 to 7.6).

Six areas requiring attention have been addressed in the preliminary design. These may be located in figure 3 and are fully described in 7.1 through 7.6. The preliminary design is further supported by figures 4 through 7.

Once the repairs in 7.2 have been completed, an earth berm can be constructed on top of the existing spillway, starting at the point where it currently begins to descend, through to the gabion structure shown in figure 3. The berm will therefore be about 19m long, 3m wide at the top, and 1,85m high. This will not require vast quantities of ground, which can be sourced from the excavated channel of the re-engineered right hand

Consideration should also be given to constructing a weir in the auxiliary spillway as indicated in figure 3, even if it is to remain as the auxiliary spillway. At the point indicated the spillway descends steeply, and a weir (either gabion, or random-rock-masonry) that is designed to dissipate the energy would virtually eliminate maintenance. Note that this spillway will only start to function the moment the flow exceeds $86\text{m}^3/\text{s}$, i.e. above the 1 in 20 year RI flood. However, it may be decided that the cheaper option is to simply do periodic repairs, since generally the proposed weir-spillway on the right flank will cater for most events.

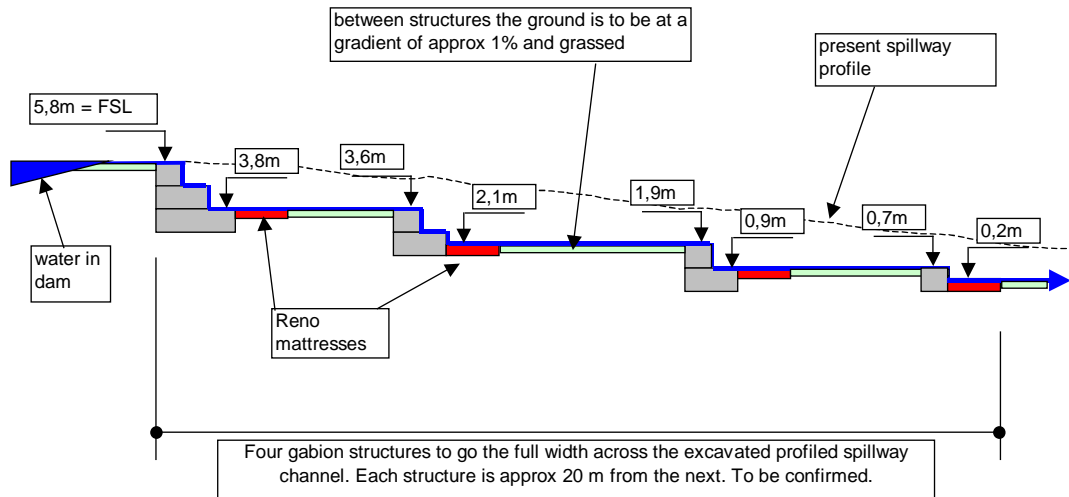
Figure 4 (a) - Section through longitudinal profile of weir-spillway showing where the various changes in elevation are likely to occur. Background structures are not shown.

In section 5 a case for a 51m wide weir-spillway was made to serve as a means of conveying storm water around the dam. In this process the energy of the water is dissipated by lowering it 5,6m from the elevation of 5,80m (FSL) to a safe 0,20m via four weirs (see figure 4(a)) strategically positioned in an excavated/profiled channel (see figure 4(b)). All levels are referenced to the invert level of the outlet valve at 0,00m. Between the weirs the excavated channel will vary in depth from approximately 1,5m to 2,5m, and have a gradient not exceeding 1%. The total length of the spillway is expected to be of the order of 60m, and the weirs are spaced approximate 20m apart.

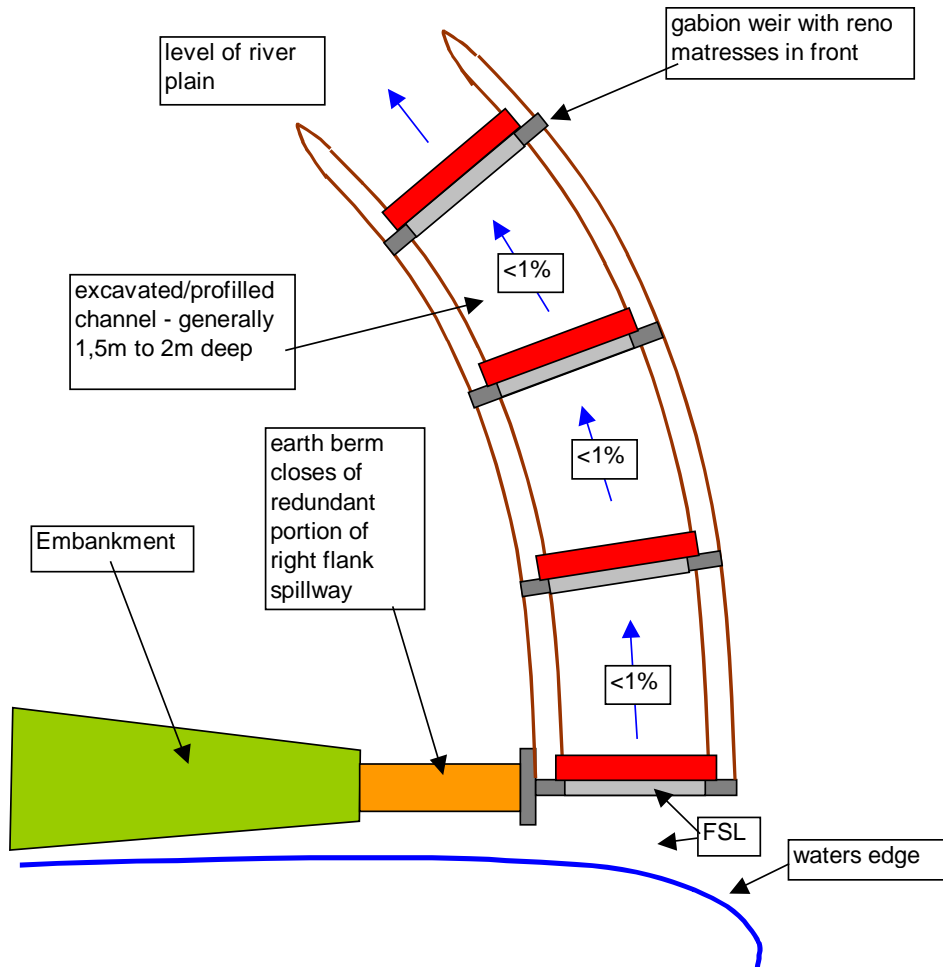
Figure 4 (b) – Plan view of spillway, showing the four gabion structures constructed across the excavated/profiled channel at strategic positions
