# REDUCING WATER LOSSES AT FERTILLIS

Client : LDA/NDZALO/RESIS

Prepared by Dr Nicholas Papenfus  
Dams for Africa (Pty) Ltd  
011 475 2764 082 416 8958

Date : 14/10/2004

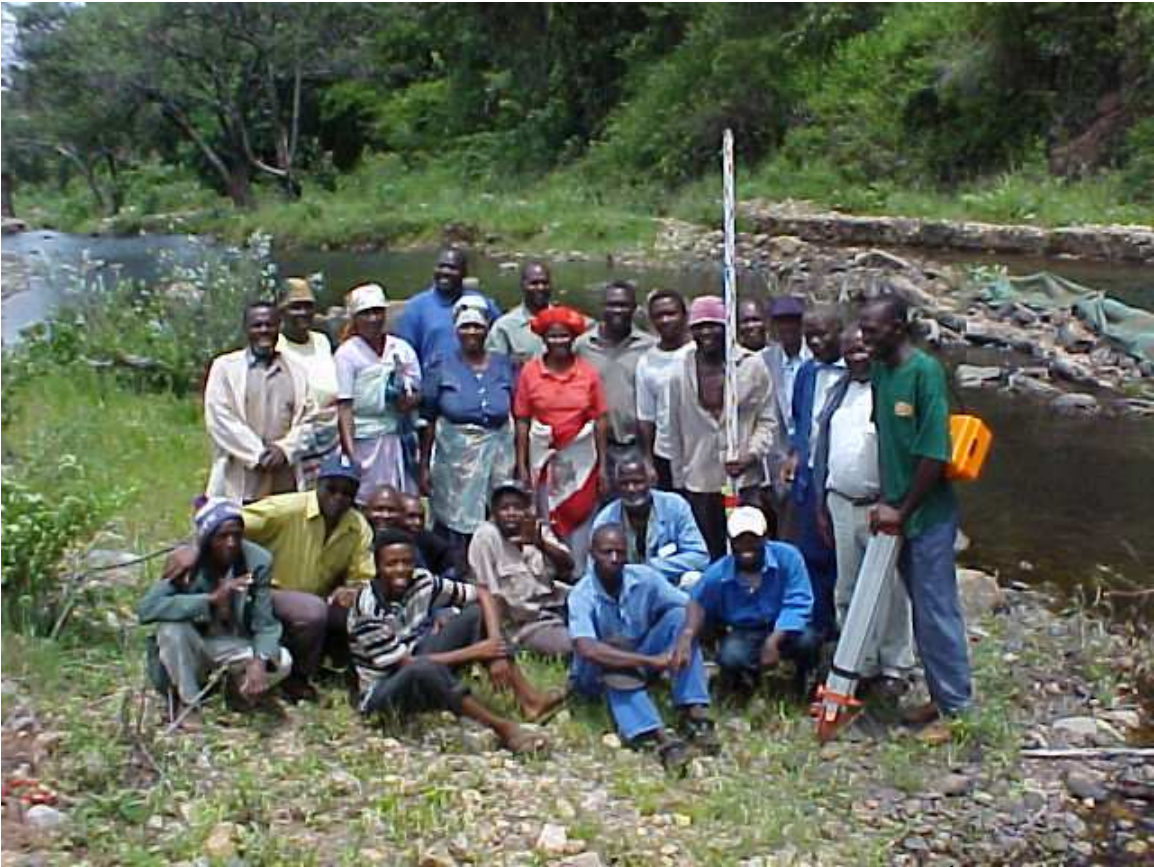
As mentioned earlier the original structure was totally destroyed during the 2000 floods. The writer witnessed this on 19<sup>th</sup> Feb 2003, and [figure 2](#) which is a picture taken on that day, shows an unsuccessful makeshift weir subsequently put together. (Following that visit and at the request of the community, the writer prepared a short report for repairing the weir and other infrastructure and a basic business plan to do commercial farming at Fertillis and Mashushu, but was unsuccessful in raising the required capital to launch the project. These two documents are appended to provide additional background information – see appendix 1 and 2 respectively - it is believed that these options may still have merit and should be considered).

**Figure 2** – A view of the hopeful farmers and committee members on 19<sup>th</sup> Feb, 2003. Their devastated weir, destroyed in the 2000 floods, is partially in view on the right of the picture. The canal leads off at the back.

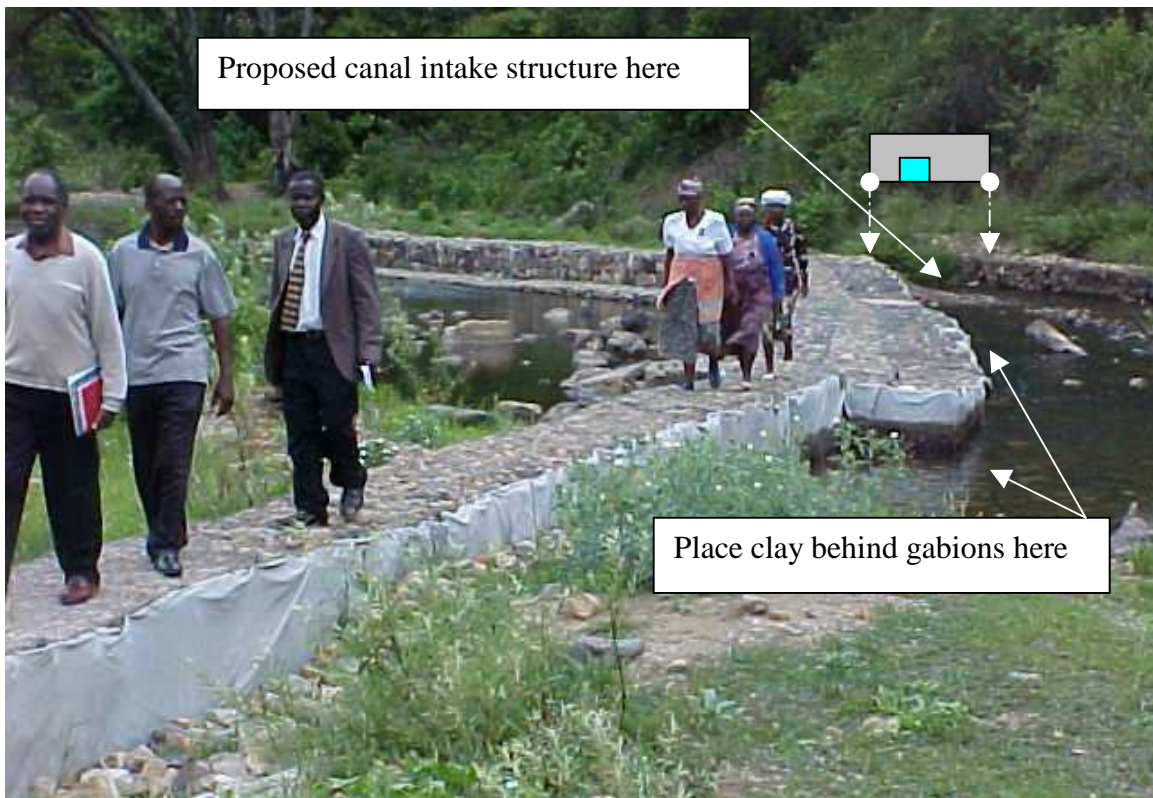
Apart from being so permeable, the weir suffers from a second inadequacy – it is not level at the top and will therefore concentrate the flow of water at the low points except for flood conditions. This will lead to wear/abrasive effects at these points, with the possibility of differential settlement that will further exacerbate the problem. It will also result in a relatively rapid rise in the height of the impounded water until the overflow is distributed evenly across the full width of the weir. This will require constant adjustment of the gate (to be constructed – see solution) so that the canal does not overflow on the one hand or deliver too little water on the other.

**Figure 3** – A view of the gabion structure built by the community in July 2003 with material supplied by the Lebowakgoma offices of the Department of Agriculture. Some of the community leaders are in picture. The geofabric may be seen on the upstream side of the weir, and decomposition from UV attack will accelerated after 2 yrs.

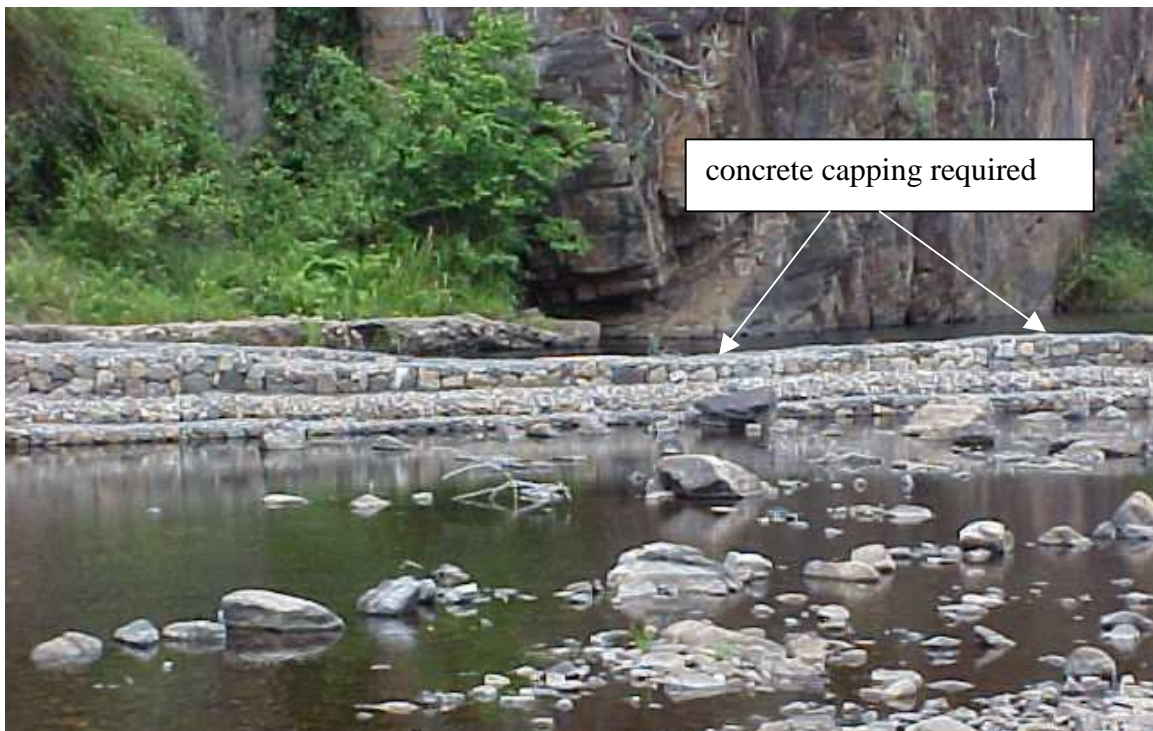
**Figure 4** – the top of the weir is not horizontal – with undulations of approximately 200mm, which may be corrected by applying a concrete topping

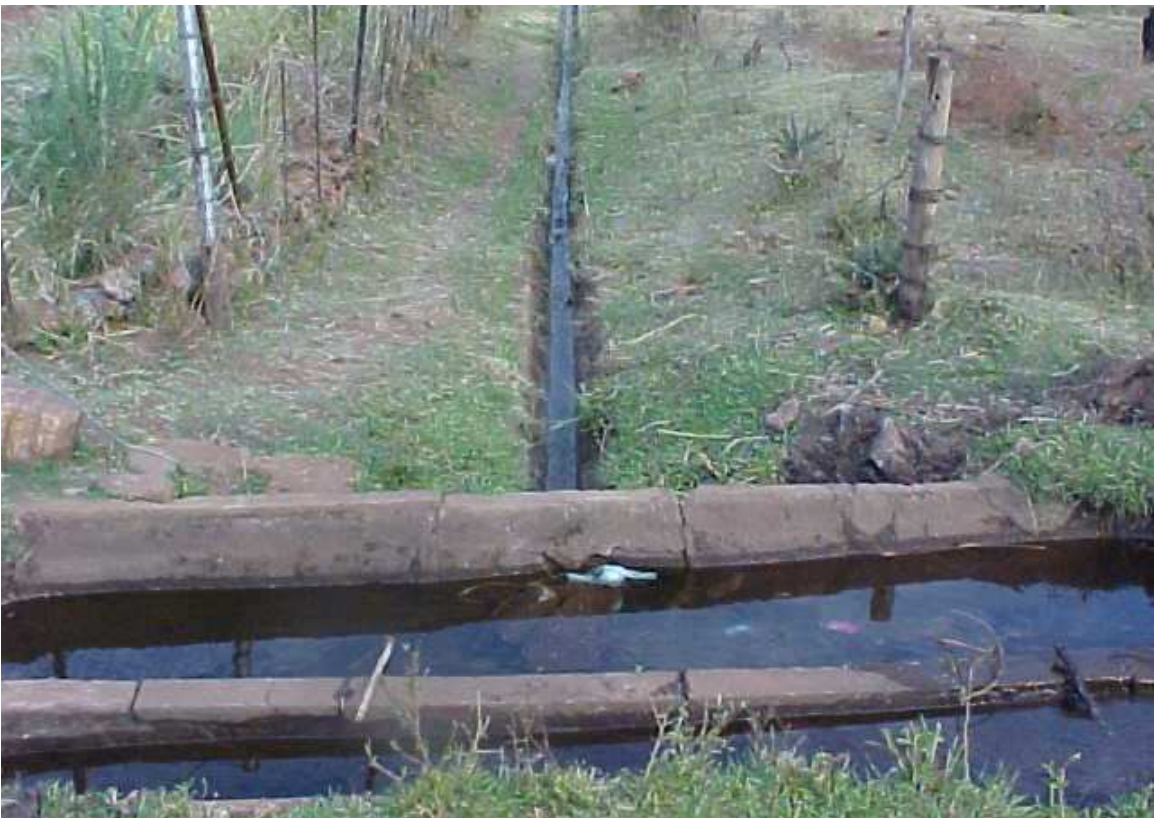
**Figure 9** – View of the first secondary canal coming off the first gate

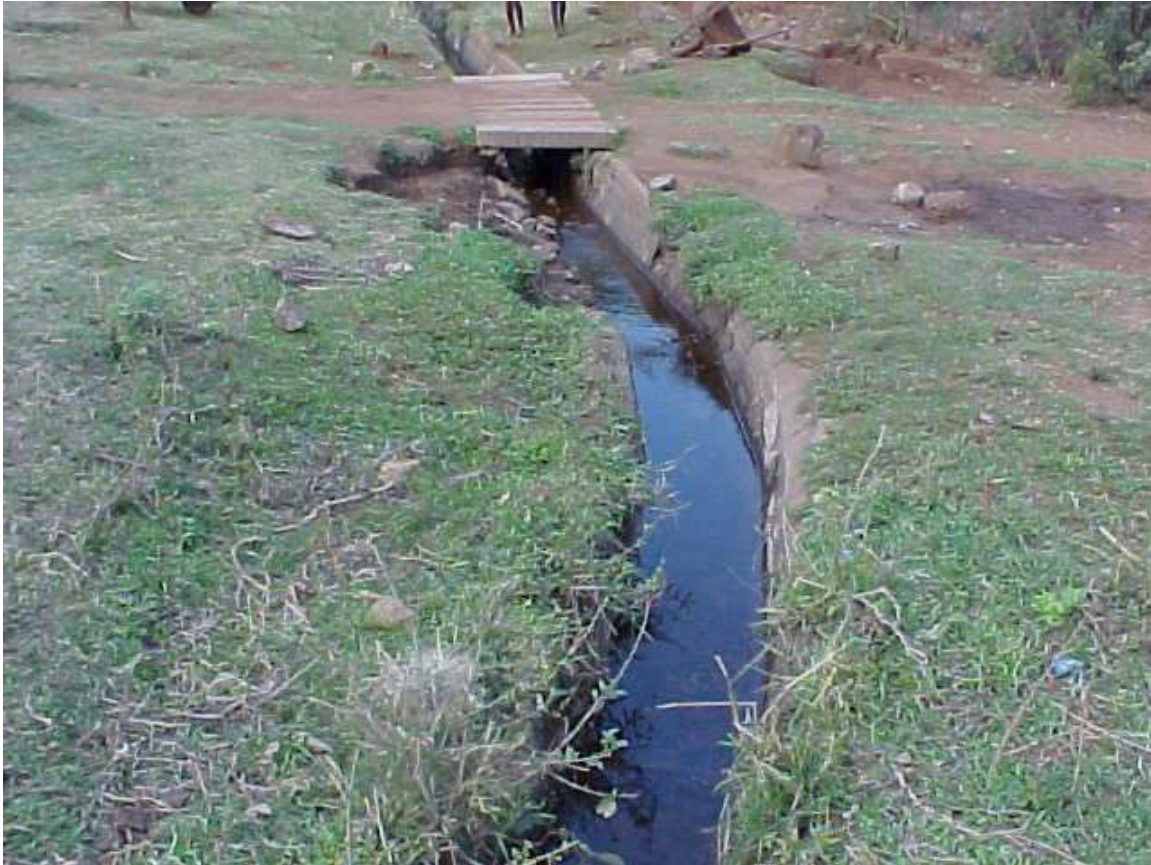
Where multiple cracks occur in close proximity to each other, or where chunks of concrete are missing, then it will be necessary to break out the broken pieces and recast.

**Figure 12** –A broken left shoulder, just before the bridge, necessitates a ‘major repair’

**Proposed Solution :** In the canal in figure 12 the left shoulder of the canal may be seen to be broken up for a stretch of about four meters. When affecting the repair, it is not necessary to break out the whole section as the right shoulder and the base are unbroken. The recommended repair in this case will take the form of figure 13. The broken pieces are taken out with a pick or a chisel and hammer. The unbroken section is trimmed into a reasonably straight line where it will interface with the new concrete. The sides of the excavation should be nearly perpendicular, and the base should extend about 50mm below the base of the old section. The inside profile can generally be achieved by trimming the concrete here with a scraper made from a 3mm plate that has the correct profile. Although a 20MPa concrete has adequate strength, 30 MPa concrete will dissolve much more slowly (calcium, the main ingredient of concrete, leaches out of its surface when it is subject to continuous flows of water, especially where the water is very pure).

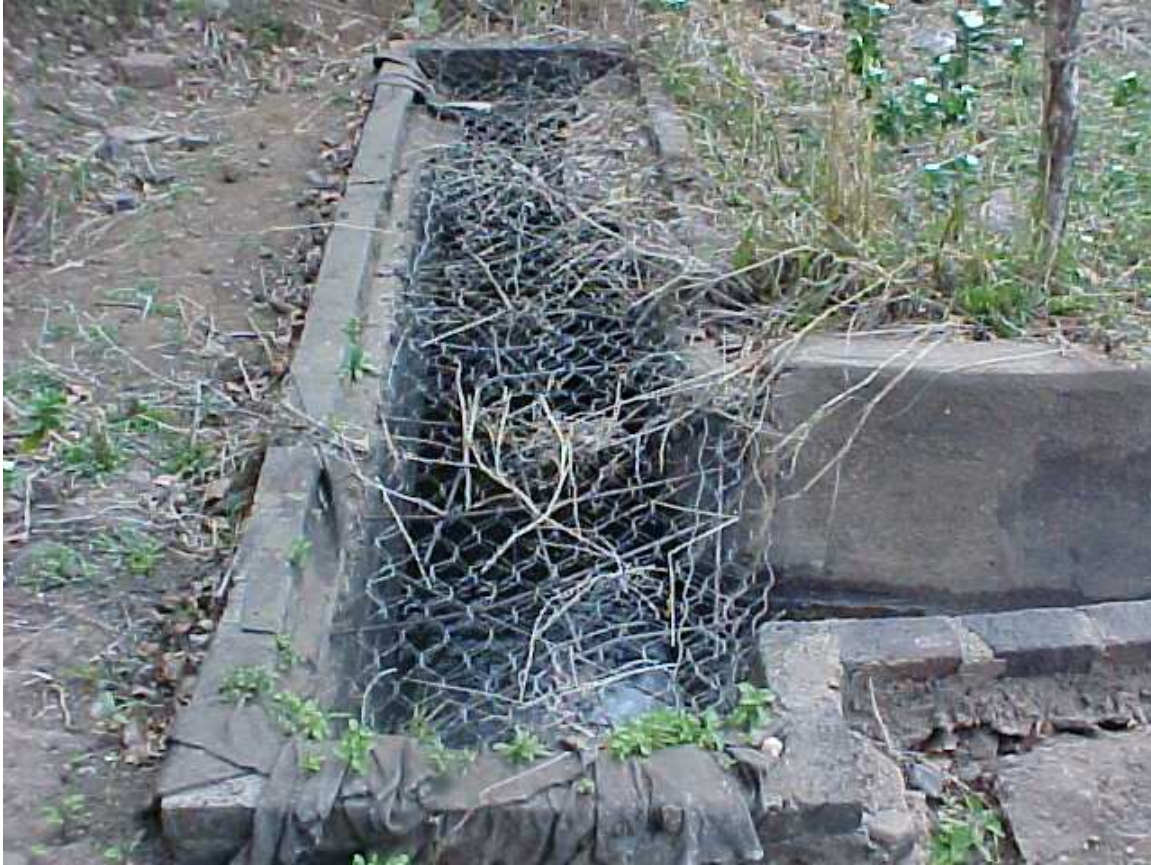
The high losses in the *principal* canal (97litres/sec down to 33 litres per sec) as recorded by Damien do not fit the observed condition of this canal, which appears to be in a good state most of the way. There are however some areas that are obviously causing leakage, notably a section of 50 m at the beginning where the canal was seriously damaged by the floods in 2000. There is also a section of about 100m where there is a buried pipeline that carries the flow. It is possible that ground settlement has occurred here so that the buried pipeline is no longer sealed, accounting for much of the observed losses. If it is confirmed that losses are indeed occurring here, then it is proposed that a surface canal be constructed so that continuity is once again established in the canal. Other than these two areas, totalling to about 150m (to be confirmed), the remainder of the canal does not require reconstruction. This represents about 10% of the length of the principal canal. The writer also inspected the primary canal by running along the length of it to get some feel of its condition (the sun was setting and walking would have meant loss of light before the end of the canal could be reached). A rough estimate of the areas requiring reconstruction would be 5% of its length, 115m. There is also an unlined section at the

**Figure 14** – Intake to 100m buried pipe. The canal may be seen to be coming in from the right.

**Cost:** Based on the above stated assumptions it is estimated that it will cost R **152 000** for reconstruction works of the main canal. It is estimated that it will cost **R 34 000** for the secondary canals, assuming again that a reconstruction is required every 50m and that each repair is 2,4m in length (same criteria as Success, to be confirmed). It is advisable that this work be given to a **specialist canal contractor**, who would employ local labour for the most part. Estimated time is **30 days for the major canal and 10 for the secondary**.

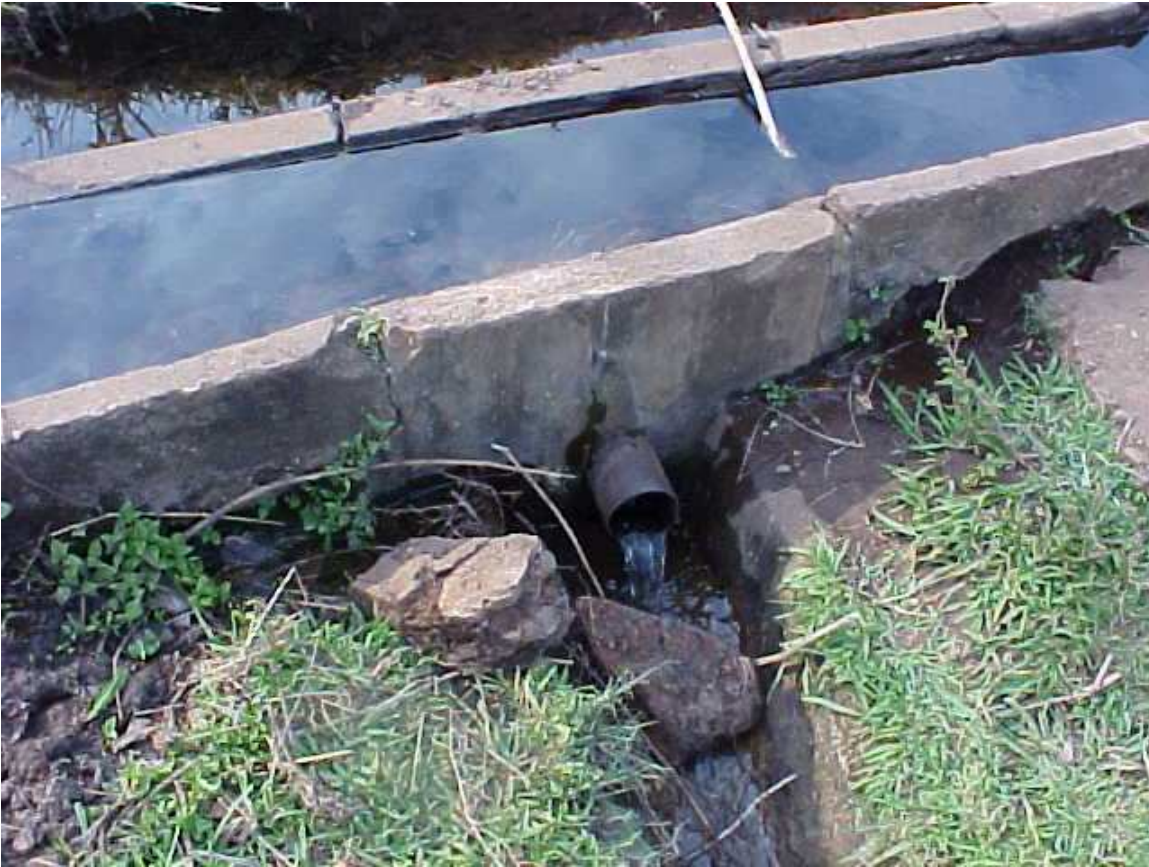
**Figure 15** – View of gate 1. Water flows from the primary canal (background) into the secondary canal by means of an 80 mm galv pipes. (In this picture the flow is slow as the pipe has been blocked with a plastic bag and rock on the other side – see figure 9).

**Proposed Solution:** The arrangement shown in figure 9 is considered by the writer as inadequate, and it is proposed that the 80mm pipe be replaced with larger 100mm pipe, which will allow 56% additional water into the canal. This arrangement will create a much better flood condition in the furrow, allowing water to move along the furrow relatively quickly, resulting in uniform soaking along its whole length. Rather than use more water, it will result in the faster and more efficient use of water.

Doing this modification will require the chiselling out of the old pipes and enlarging the hole slightly after which a new 100mm pipe may be epoxied in. (The use of epoxy is recommended to achieve a strong bond between the pipe and old concrete, given that the pipe will be subjected to constant handling/turning motions - the pipe may get loose if it is fastened only with a cement based grout). The proposed new arrangement is shown in figure 16.

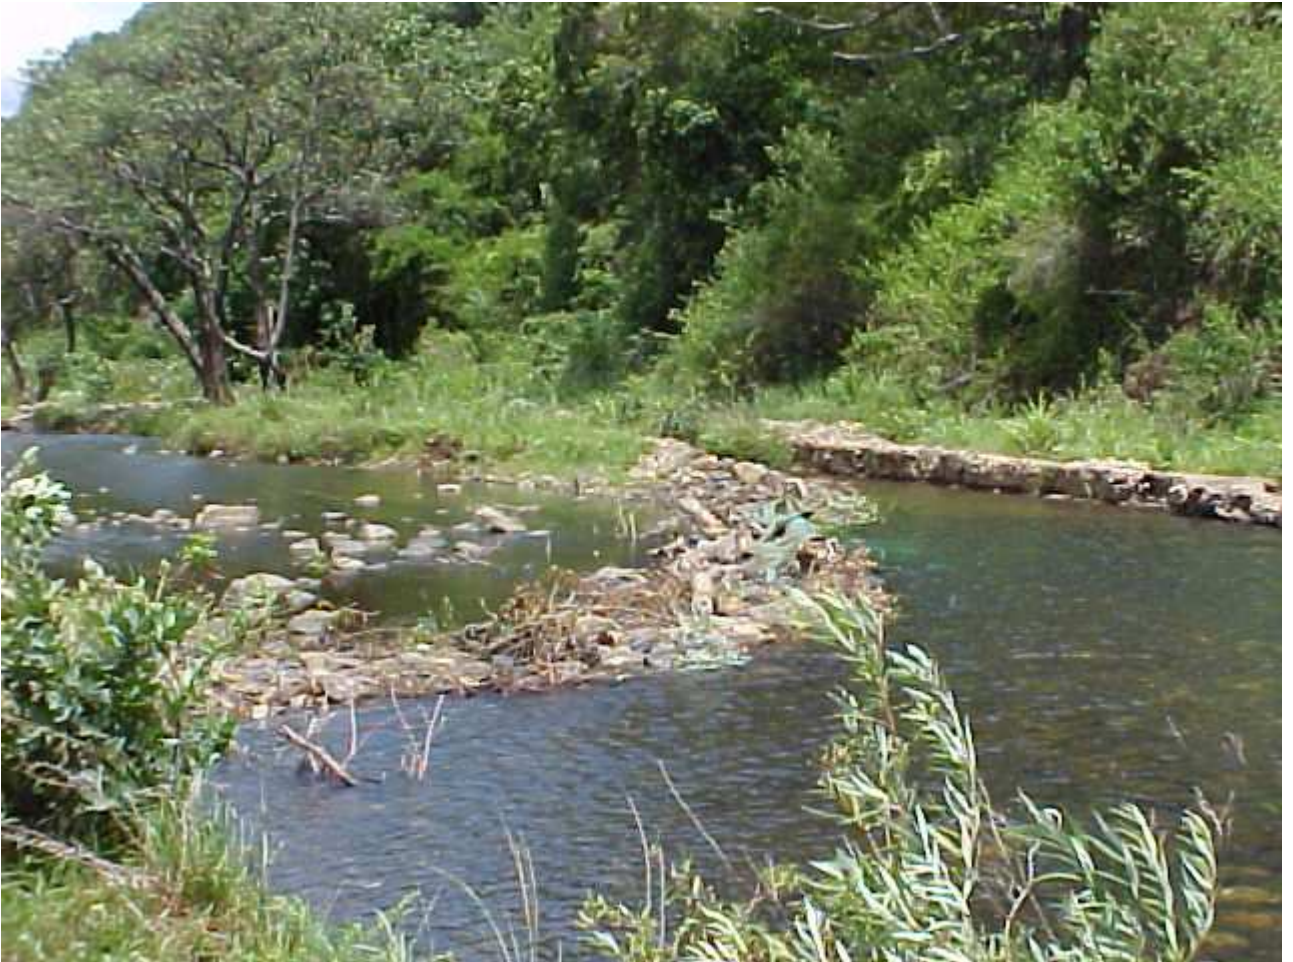
Sadly, the extreme floods in 2000 damaged the weir to such an extent that the water in the river now flows past the canal. This has given rise to a very serious situation - the drought conditions have largely resulted in failure of the summer crops – and famine is looming unless winter crops such as vegetable can be grown. This however requires irrigation, and to do this the level of the weir needs to be raised by about 400mm, so that water will once again be diverted into the canal. The weir in its current state can be seen in figure 2. The current operating level in the canal can be seen in figure 3.

**Figure 2** – The flood damage to the diversion weir is evident. Water currently percolates freely through crude rock/soil makeshift structure. The upstream level should be approximately 400mm higher than at present in order to divert enough water into the canal. The mouth of the canal is out of view, but is to the top centre of the picture.

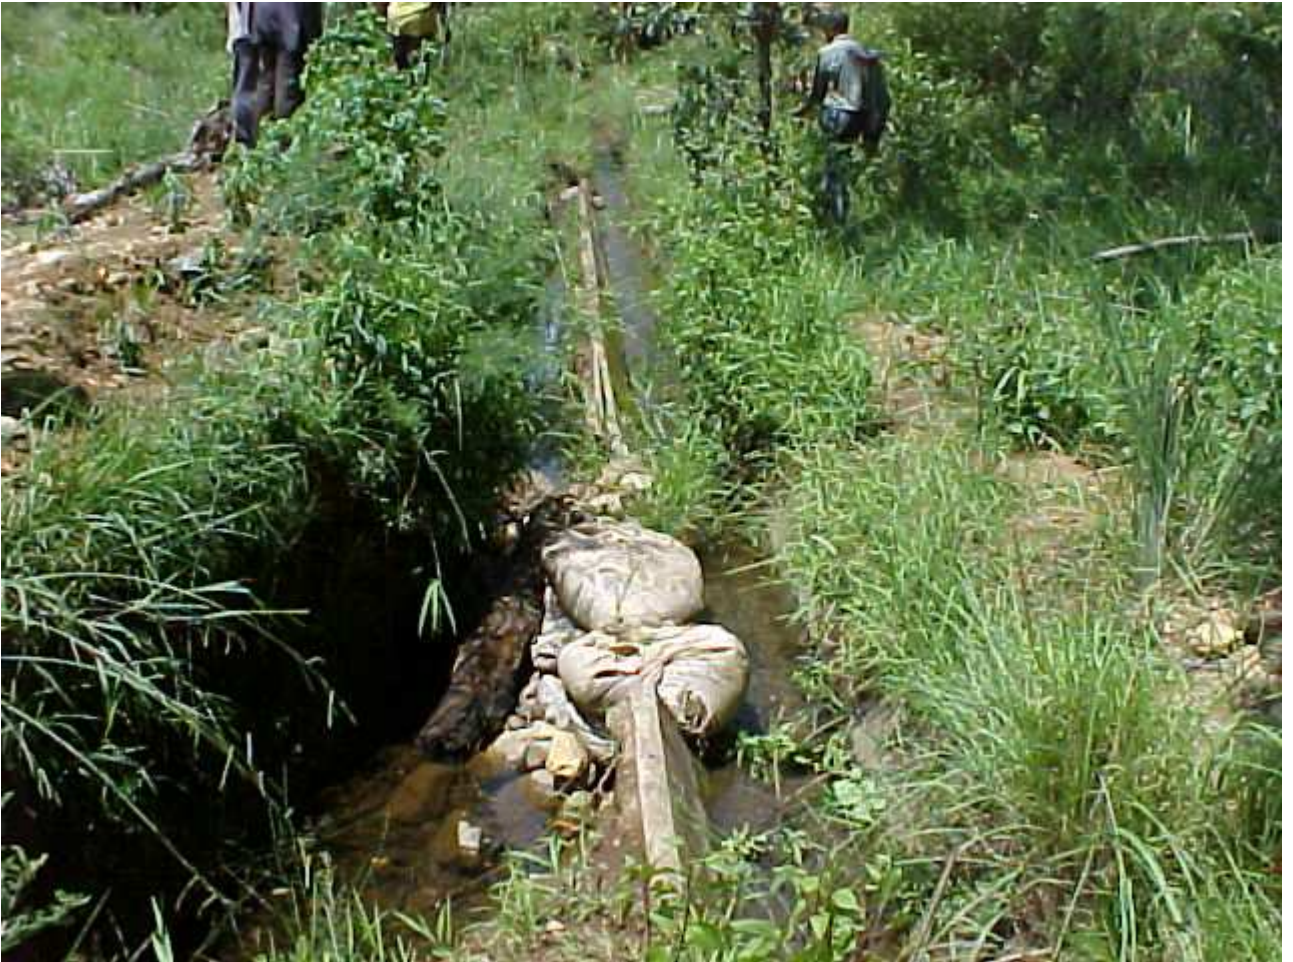
**Figure 3** : The low level of the water in the reservoir results in minimal water flowing in the canal. An unsuccessful attempt to bring in water from the side was made.

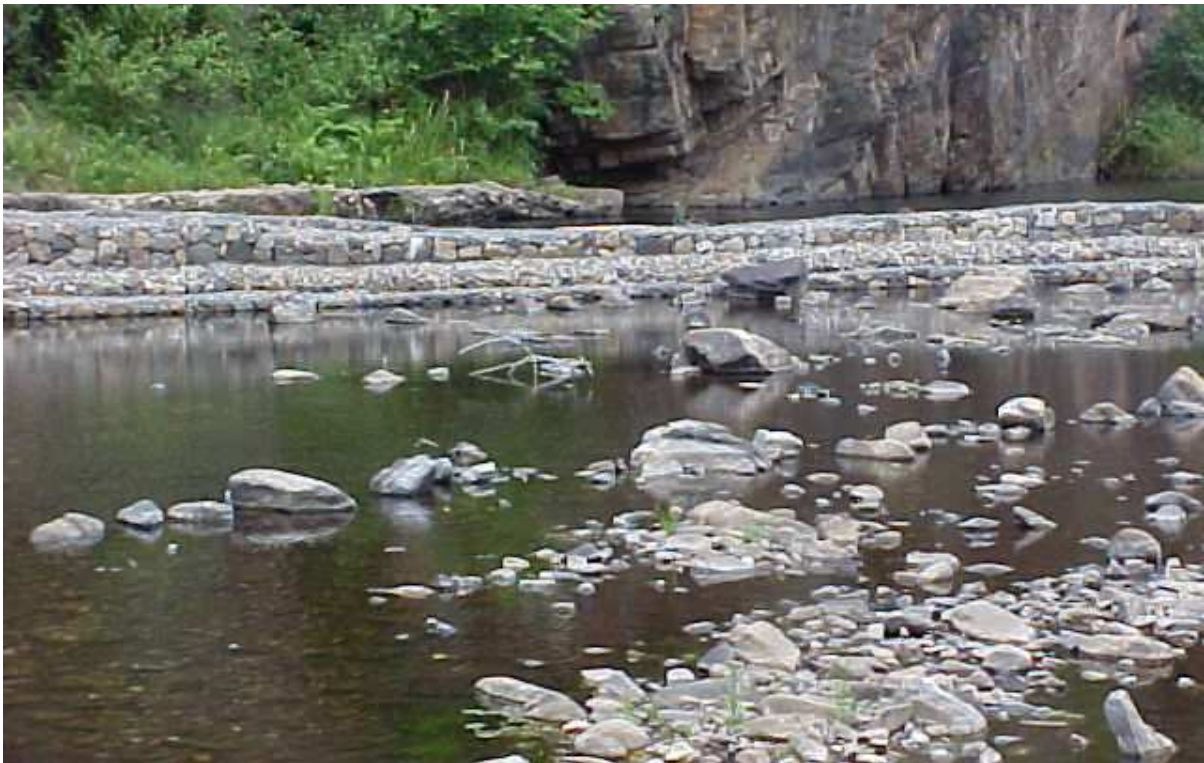
1. Water flows freely through the gabions, and as a result the impounded water does not rise sufficiently for water to be diverted into the canal.
2. There is no means of controlling the amount of water that will go down the canal. Thus the flow in the canal depends solely on the level of the impounded water – which in turn depends on the amount of water coming down the river.
3. There is no flood control barrier at the entrance to the canal to protect it from excessive flows in flood conditions. This has resulted in water undermining the canal (see figure 4).
4. The top of the gabion weir is not level, rising and falling substantially in places. This means that instead of water flowing over it in an even sheet, it will be concentrated in places, thus increasing the probability of damage at these places.

**Figure 3** - Upstream view of gabion weir – the water in the river passes directly through the gabions, and virtually no water goes into the canal.

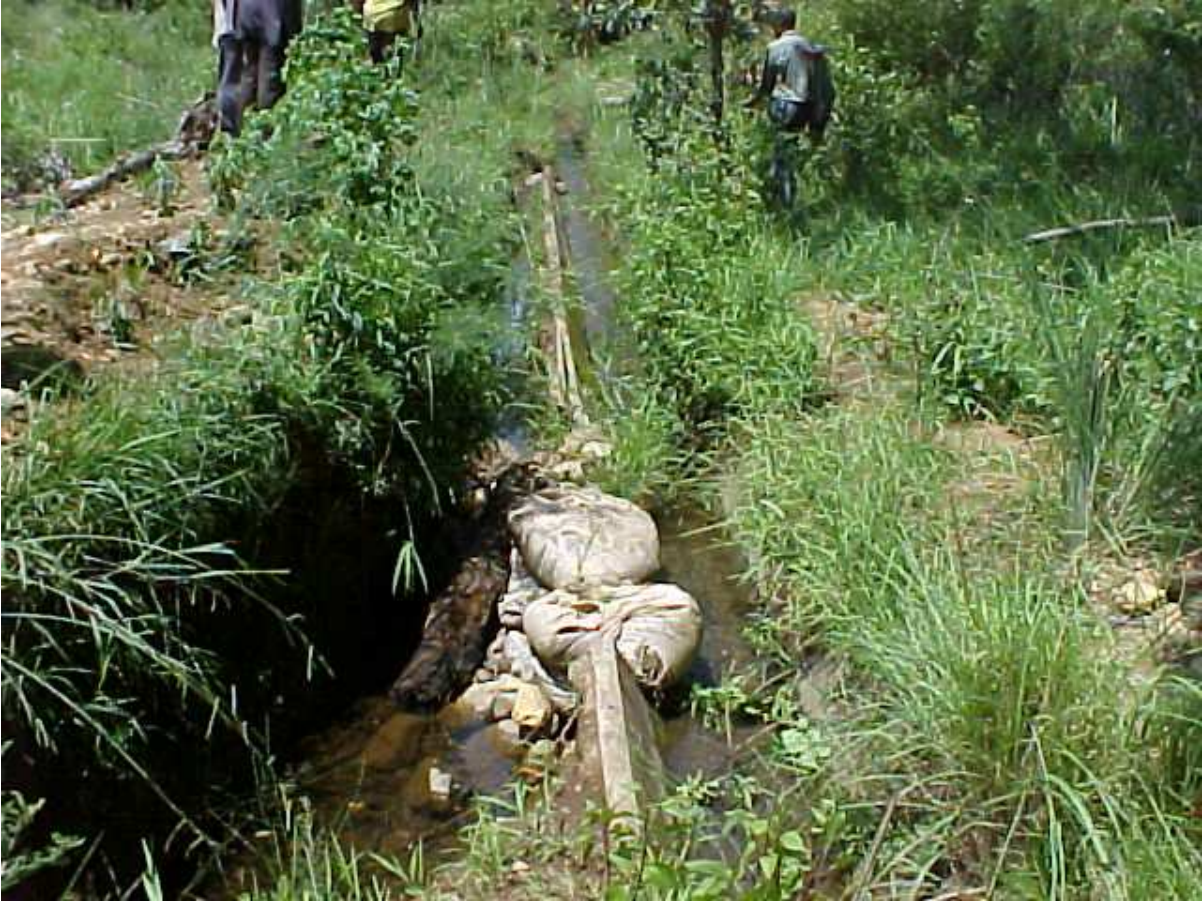
**Figure 4** - The upstream level is too low to make the water flow in the canal. Notice how the supporting material has been eroded because there is no barrier wall at the start of the canal.
