Chapter 5

Site Testing

5.2 Paving at Westgate

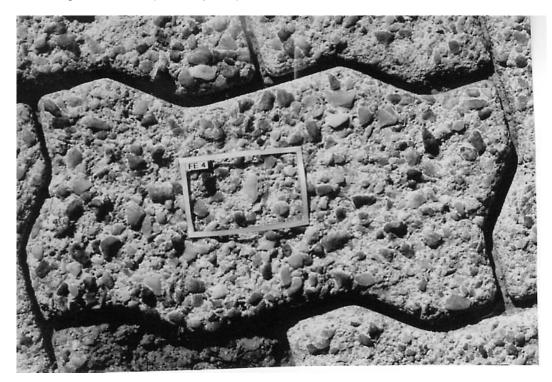
Figure 5.4 Example a of block visually assessed to have fourth degree abrasion.

From figure 5.4 it may be seen that a photograph is an excellent means of illustrating wear.

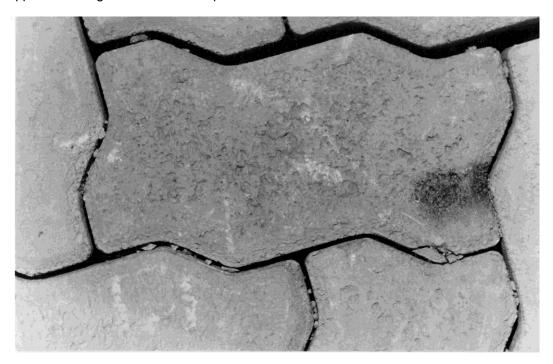
Figure 5.5 'Before wear' photograph of a newly installed block at Westgate. The photograph illustrates the 'before wear ' surface texture, which is relatively rough in this instance, owing to this mix being purposely made with too much water. A rough / rippled surface texture is characteristic of blocks from a very wet mix.

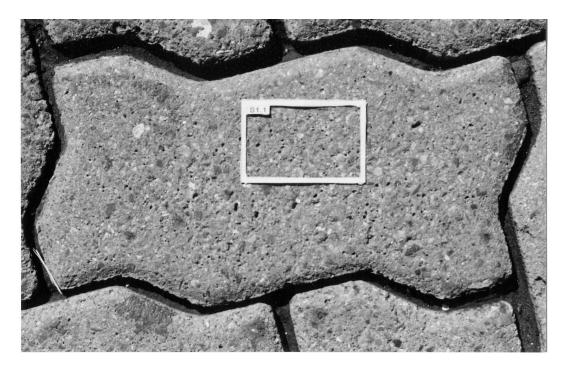
Figure 5.7 'After wear' photograph of full block, after five and a half years of pedestrian traffic.

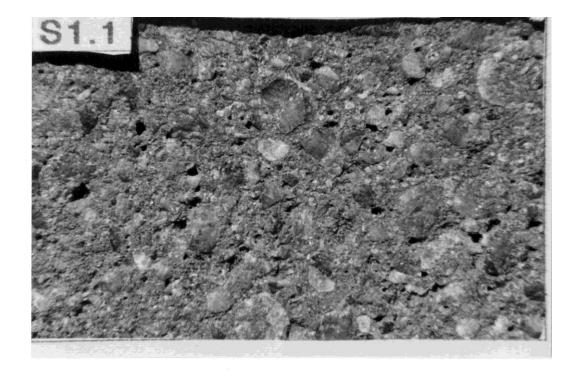
Figure 5.8 Magnified view of 50 mm x 30 mm frame facilitates a critical analysis of the surface texture.
