# Rehabilitation of Outlet Structure

Dams for Africa (Pty) Ltd.

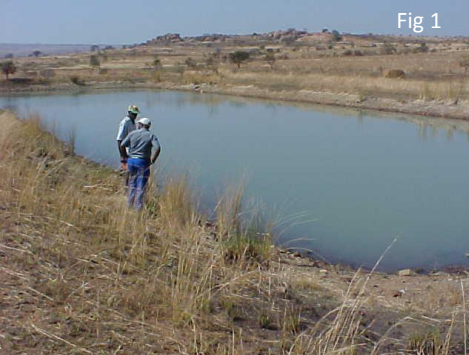
Fig 1

The 'canal dam' (see fig 1) at Mabintwane village, Nebo district, Limpopo, was designed to operate as a balancing dam. By night a canal from the Motsephiri river would fill the reservoir so that by day the local farmers could flood-irrigate their crops.

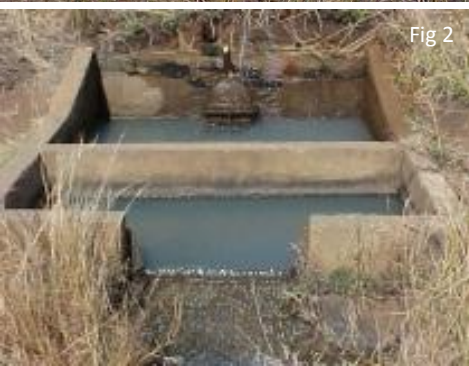
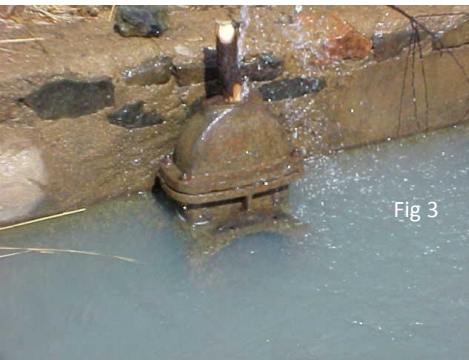
However, over the course of time the outlet's gate valve (see figs 2 & 3) had become non-functional, and significant leaks had developed. To make matters worse the nuts/bolts holding the valve to the concrete wall had 'rusted' together, and the bolts would have snapped if an attempt to remove the nuts was made.

On the other hand the front flange of the valve was still in good order, so that the new valve could be bolted to it. It was therefore decided to leave the old valve in position, and encase it with concrete to seal the leaks.

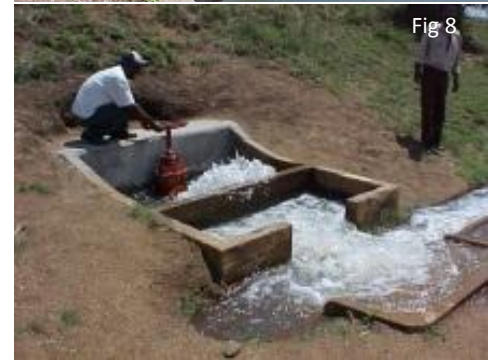
Fig 8

These relatively simple and cost effective actions made it possible to once again make the reservoir fully functional again (see fig 8).
