Report # 1

Report on Spurwing Dam, Letata, Dullstroom

Cutwater Farms (Pty) Ltd

April 2004

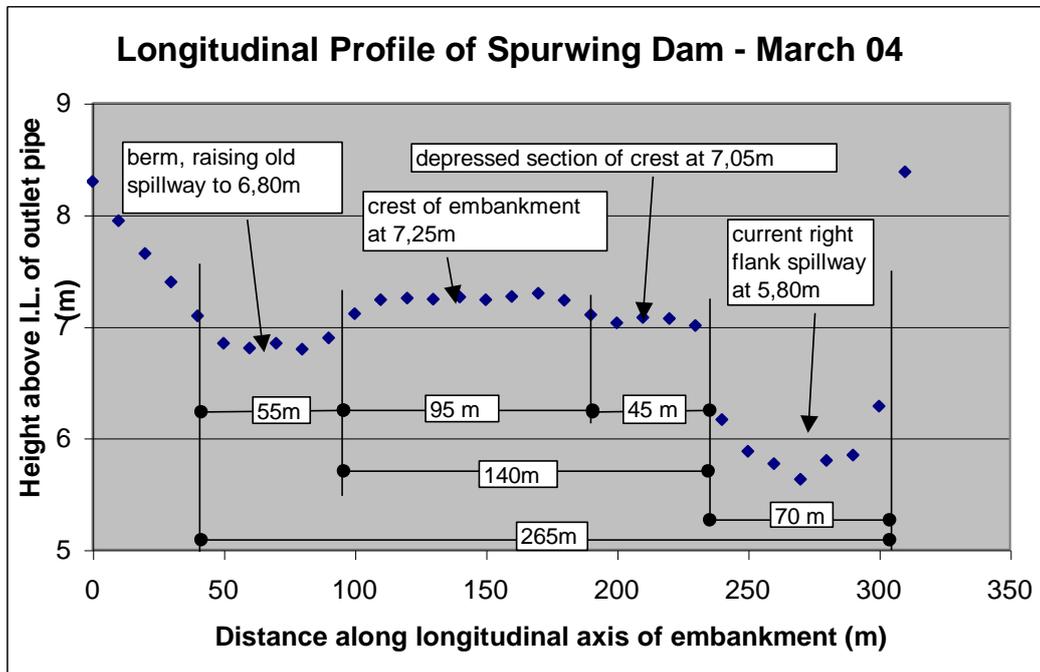
Figure 1 – Longitudinal Profile of Spurwing Dam. All levels are referenced to the invert level of the outlet valve, and are spaced 10m apart. The current right flank spillway has on average an elevation of 5,8m, while the left flank spillway begins to function when the water rises to a height of 6,8m, as this is the elevation of the crest of the road/berm that now traverses it. The crest of the embankment between the two spillways is at an elevation of approximately 7,25m, except for a 45m stretch on the right which is about 0,2 m lower.

It is evident from figure 1 that the crest of the embankment is virtually horizontal. This is generally an indication of an embankment that was well compacted during the construction stage. All embankment dams consolidate (compact under their own weight with time) to a greater or lesser extent, and clearly consolidation will be greater where the embankment is highest. So for an embankment to still be virtually horizontal and not V shaped after 12 years implies that it was very well compacted at the construction stage. A well compacted embankment generally has good shear strength and hence the various forms of shear failure that are possible are most unlikely even for the increased forces associated with a possible overtopping event (to be discussed later). It also means that it will not erode as easily as would a poorly compacted embankment in the event of water flowing over the crest and down the embankment during overtopping.

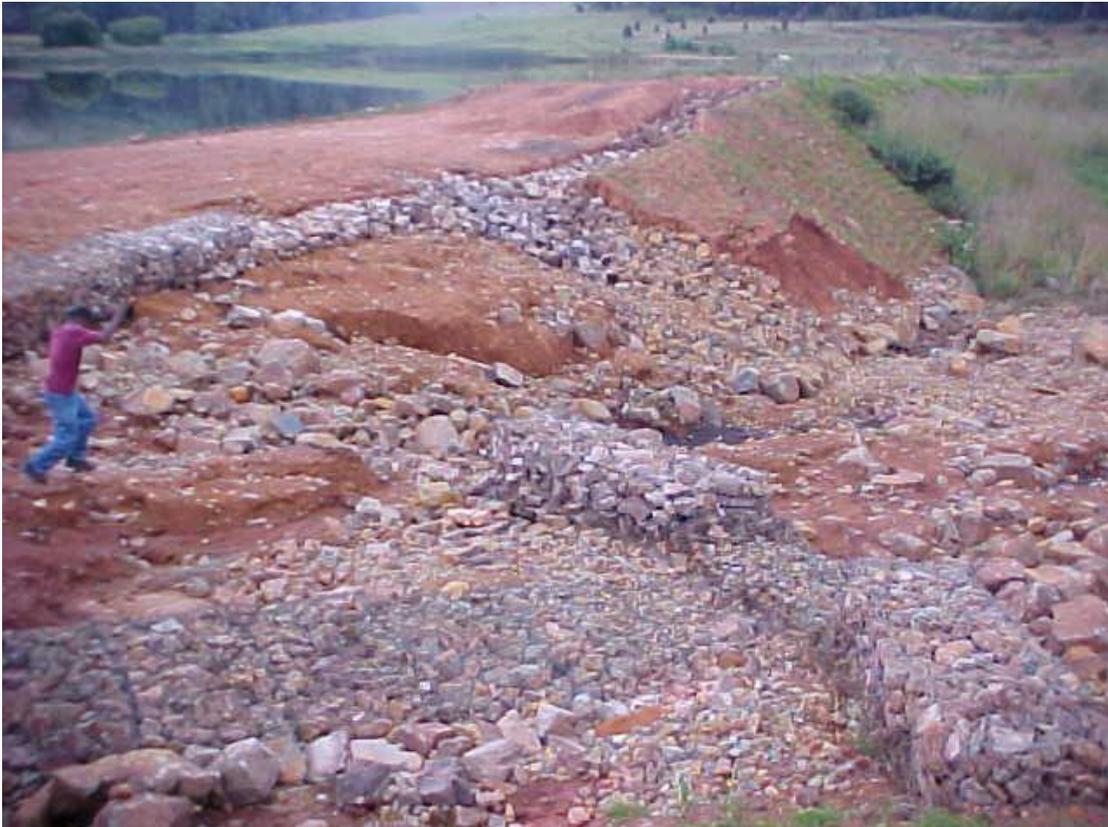
- 5.5 In the foreground of figure 2 a small gabion structure may be seen, and there are a number of these structures immediately upstream of the one in view.

Presumably they were intended to keep the residual flow of the river away from the toe of the embankment. However, they are too insignificant to cope with flows generated by heavy rainfall in the catchment, let alone flood events. Therefore the proposed design calls for a series of weirs of a much sturdier configuration that span the full width of the 51m channel, creating steps that lower the water up to 2m at a time (see figure 4). The gabion cages and rocks that have been used in these structures can be reused to construct the new structures.

Figure 2 – This picture illustrates how several of the requirements for a spillway have been overlooked. The spillway is far too steep (see requirement 4.3.4) and consequently significant erosion is evident. It is also evident that the water that flows over the left side of the spillway discharges its water directly down the embankment (see requirement 4.3.3). The crossflow in the spillway channel (see requirement 4.3.7) results in water flowing against the toe of the embankment, and this has resulted in erosion for a considerable distance.

As indicated in figure 2 and 3 the effected areas are not large, and the repairs can thus be effected relatively easily with simple compaction equipment.

As explained in 5.3 the current right flank spillway discharges part of its water directly over the embankment. This has resulted in the toe of the embankment being washed away in this area and a degree of shear failure has occurred. The embankment is also very steep in this zone approaching an angle of 1 in 1,3, and this should be brought in line with the rest of the embankment.

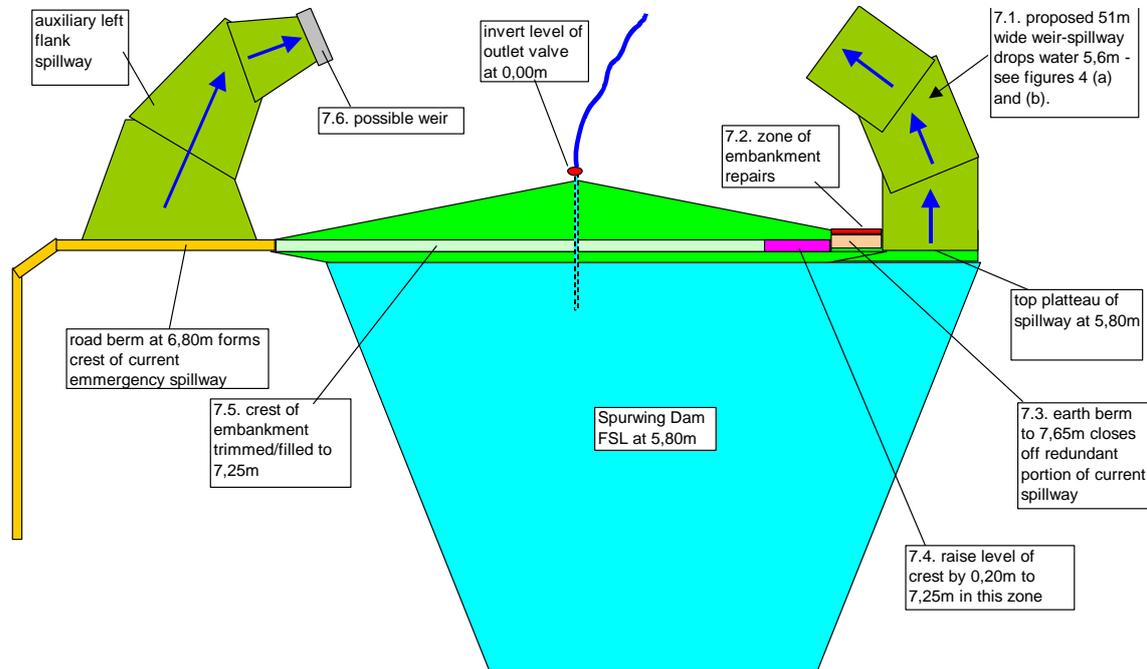
Figure 3 – Schematic Plan of Spurwing Dam indicating proposed scheme of work (7.1 to 7.6).

Six areas requiring attention have been addressed in the preliminary design. These may be located in figure 3 and are fully described in 7.1 through 7.6. The preliminary design is further supported by figures 4 through 7.

Once the repairs in 7.2 have been completed, an earth berm can be constructed on top of the existing spillway, starting at the point where it currently begins to descend, through to the gabion structure shown in figure 3. The berm will therefore be about 19m long, 3m wide at the top, and 1,85m high. This will not require vast quantities of ground, which can be sourced from the excavated channel of the re-engineered right hand

Consideration should also be given to constructing a weir in the auxiliary spillway as indicated in figure 3, even if it is to remain as the auxiliary spillway. At the point indicated the spillway descends steeply, and a weir (either gabion, or random-rock-masonry) that is designed to dissipate the energy would virtually eliminate maintenance. Note that this spillway will only start to function the moment the flow exceeds $86\text{m}^3/\text{s}$, i.e. above the 1 in 20 year RI flood. However, it may be decided that the cheaper option is to simply do periodic repairs, since generally the proposed weir-spillway on the right flank will cater for most events.

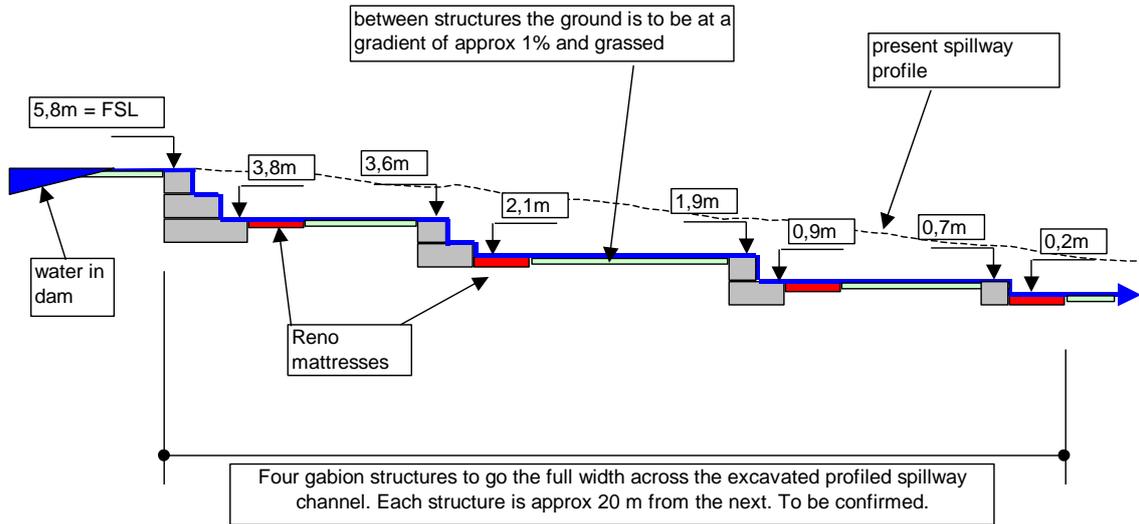
Figure 4 (a) - Section through longitudinal profile of weir-spillway showing where the various changes in elevation are likely to occur. Background structures are not shown.

In section 5 a case for a 51m wide weir-spillway was made to serve as a means of conveying storm water around the dam. In this process the energy of the water is dissipated by lowering it 5,6m from the elevation of 5,80m (FSL) to a safe 0,20m via four weirs (see figure 4(a)) strategically positioned in an excavated/profiled channel (see figure 4(b)). All levels are referenced to the invert level of the outlet valve at 0,00m. Between the weirs the excavated channel will vary in depth from approximately 1,5m to 2,5m, and have a gradient not exceeding 1%. The total length of the spillway is expected to be of the order of 60m, and the weirs are spaced approximate 20m apart.

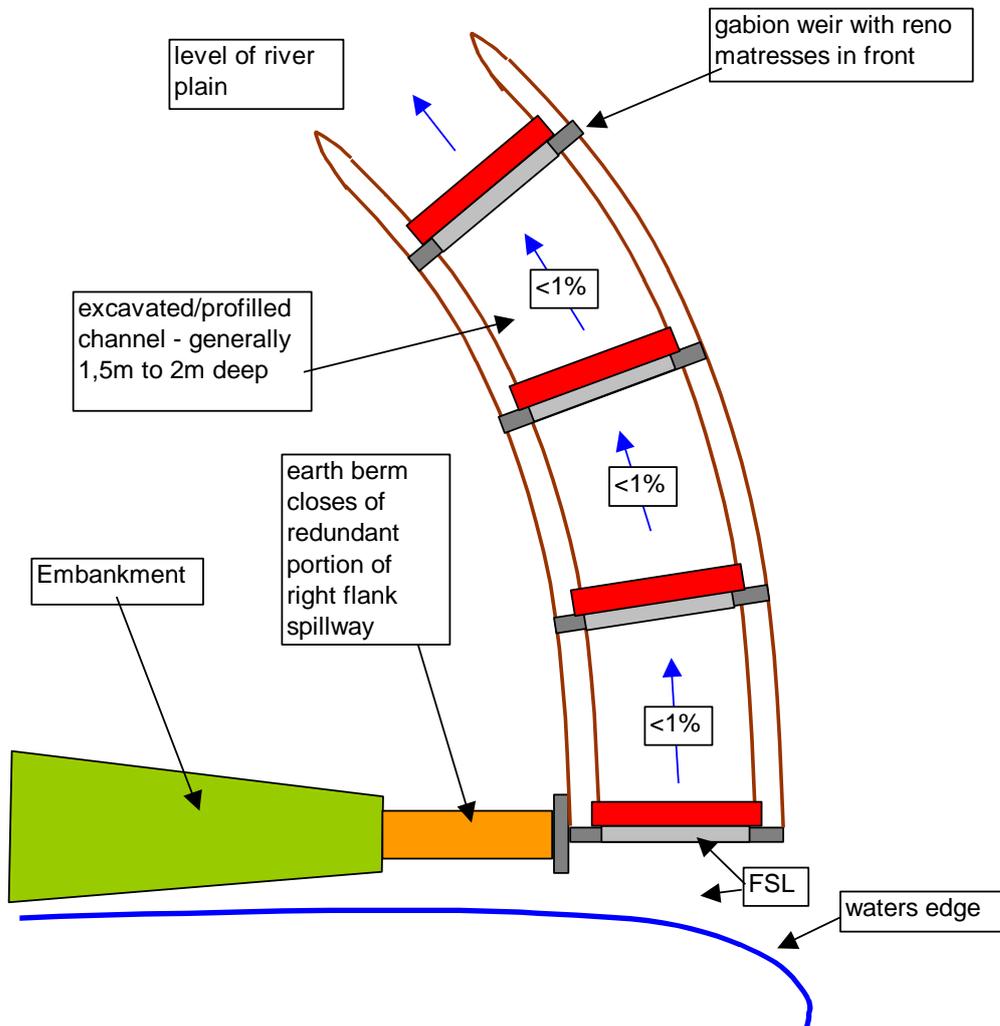
Figure 4 (b) – Plan view of spillway, showing the four gabion structures constructed across the excavated/profiled channel at strategic positions
