Rehabilitation of crest

Dams for Africa (Pty) Ltd.

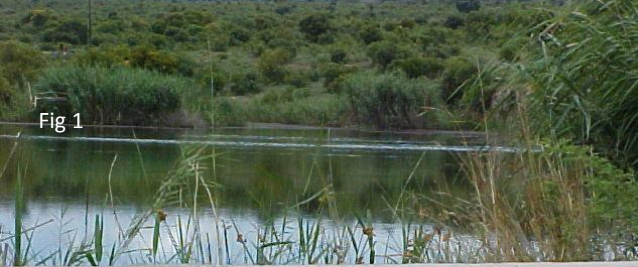
The '1951 dam' situated near the village of Mabintwane, Nebo District, Limpopo, was built for crop irrigation and livestock watering – fig 1 is taken from the crest of the dam overlooking the reservoir.

In 2002 Dams for Africa constructed a 500 mm wide x 300mm high concrete strip over the full length of the crest (see figs 1, 5, 6) – taking care to make its top horizontal. Not only does this ensure that future topplings will occur as a thin and relatively innocuous sheet of water, but the free board is increased by the additional height added to the crest, ensuring that substantially greater flows will go through the two spillways, thus lessening the occurrence and duration of future crest topplings.

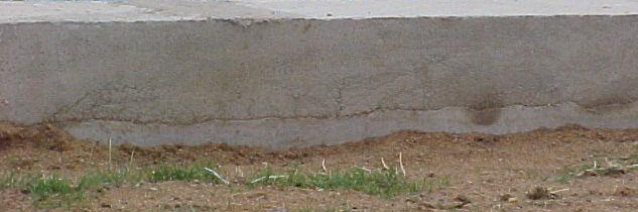
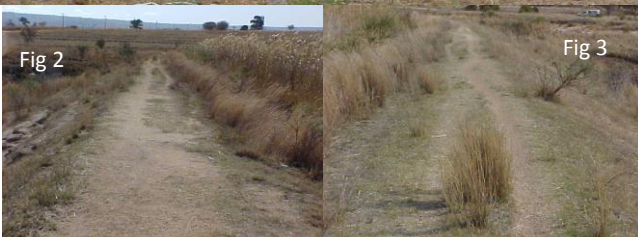
Inevitably a degree of non-uniform consolidation occurred over the years, with the result that the crest became somewhat undulating (see figs 2 & 3). According to the local population the crest has been topped a number of times during heavy storms. When this happens the water starts to flow over the lowest sections of the undulating crest first, and the result is substantially increased erosion of the embankment's downstream slope at such points – see fig 4.
