Report on Spurwing Dam, Letata, Dullstroom

Cutwater Farms (Pty) Ltd

Prepared by Nicholas Papenfus

April 2004

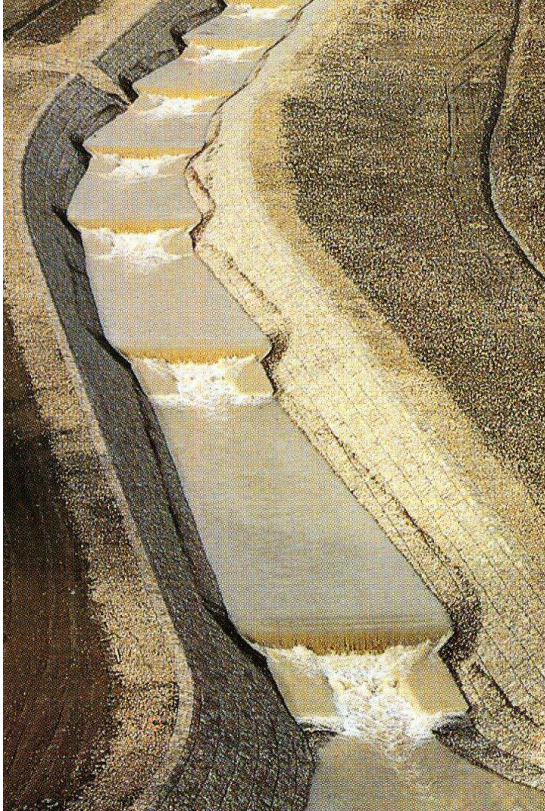
Figure 5 – Example of a weir-spillway in Italy, constructed of gabions and renomattresses. The large drops in elevation take place at the gabions, allowing much reduced velocities in the channel between the gabions.

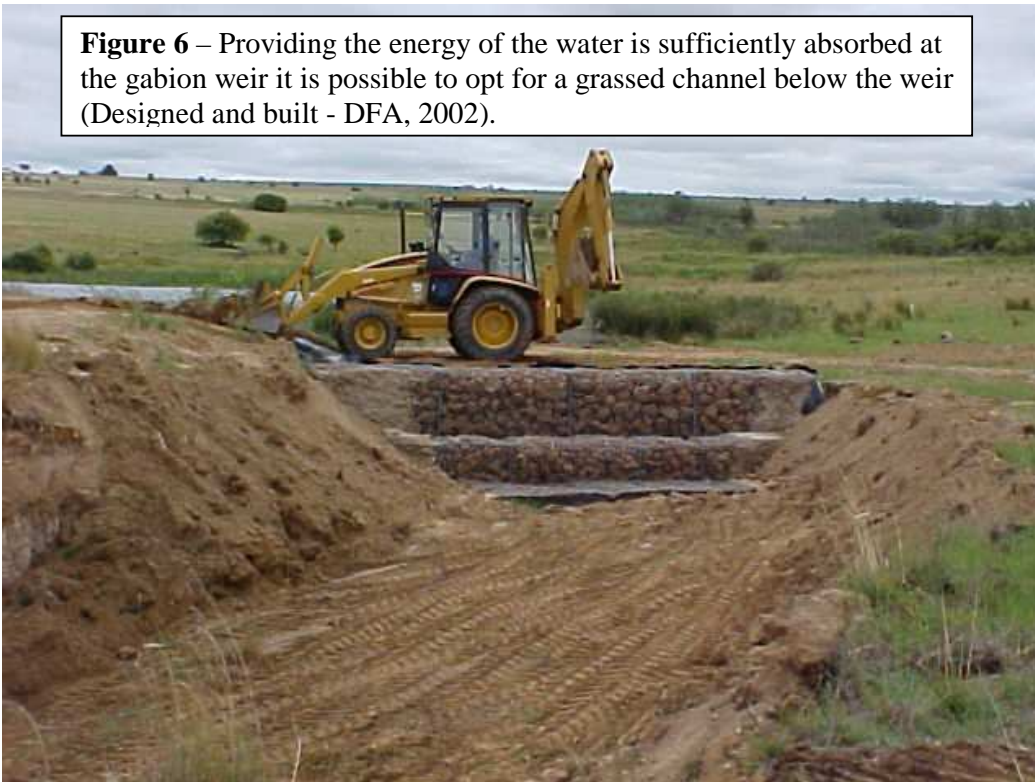
Figure 6 – Providing the energy of the water is sufficiently absorbed at the gabion weir it is possible to opt for a grassed channel below the weir (Designed and built - DFA, 2002).

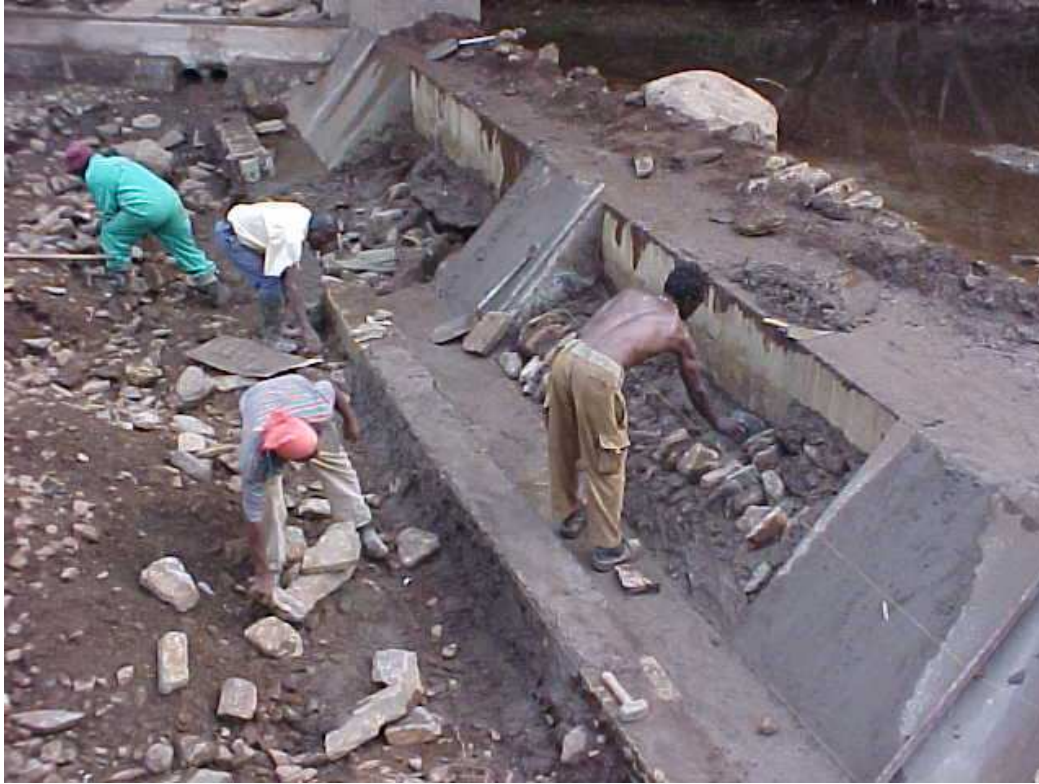
Figure 7 – Where ground is well consolidated it may be cost effective to construct the weir from a more rigid system such as random-rock-masonry as shown here. Much of the ground from which the re-engineered spillway is to be constructed is either undisturbed or well compacted, making this type of construction an option in the final design, if better suited than gabions. This diversion weir is situated in a gorge that has a 130km² catchment. (Designed and built – Dams for Africa 2003/4).
