# REDUCING WATER LOSSES AT FERTILLIS

Client : LDA/NDZALO/RESIS

Prepared by Dr Nicholas Papenfus  
Dams for Africa (Pty) Ltd  
011 475 2764 082 416 8958

Date : 14/10/2004

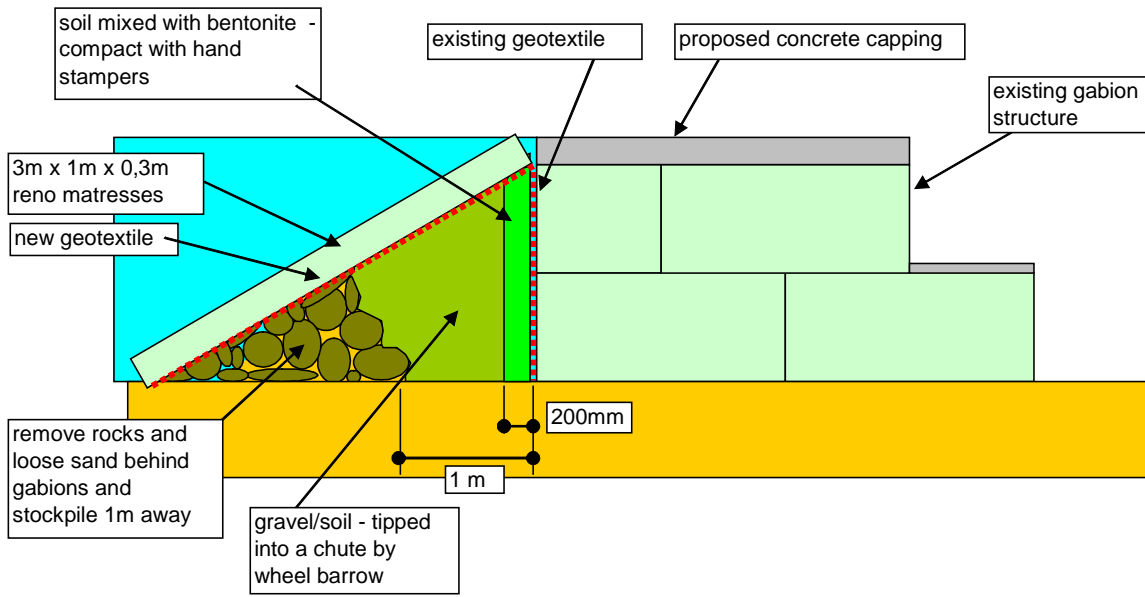
However, there is an alternative solution whereby the ‘gabions’ are sealed by placing earth behind the geotextile. Once a temporary diversion canal has been excavated as shown in [figure 5](#), the loose rocks and loose sand immediately behind the gabions are moved a distance of about 1m away from the structure (see figure 5), and then a 200mm layer of bentonite/soil mixture is placed immediately against the geotextile and compacted using hand stampers. Behind this material, gravelly/soil should be placed to provide lateral support. This material may be sourced from the river bed upstream or downstream, and should be selected such that the proportion of gravel and soil will compact sufficiently simply by the action of trampling on it. This material may be brought in by wheel barrows running on top of the existing structure and then be thrown into a simple chute that directs it behind the bentonite/soil layer to provide it with lateral support. The gravel/soil is in turn supported by the rocks that were removed and stockpiled earlier – see figure 5. Finally a 3m long Reno mattress structure, lined beneath with geofabric, is constructed on top of these elements to protect the clay from wave action and to keep it from washing away in flood conditions.

**Figure 5** - Section A A (relative to figure 6) through the gabion structure, showing the proposed method of sealing it.

**Cost:** It is estimated that the cost of making the existing gabions structure essentially impermeable will be **R 63000**, on the basis of the community doing the work under the supervision of a ‘[turnkey engineer](#)’. A team of [6 persons](#) should be able to complete the work in [21 days](#), while a TLB is budgeted for one week to bring in the soil, gavel, rocks etc.

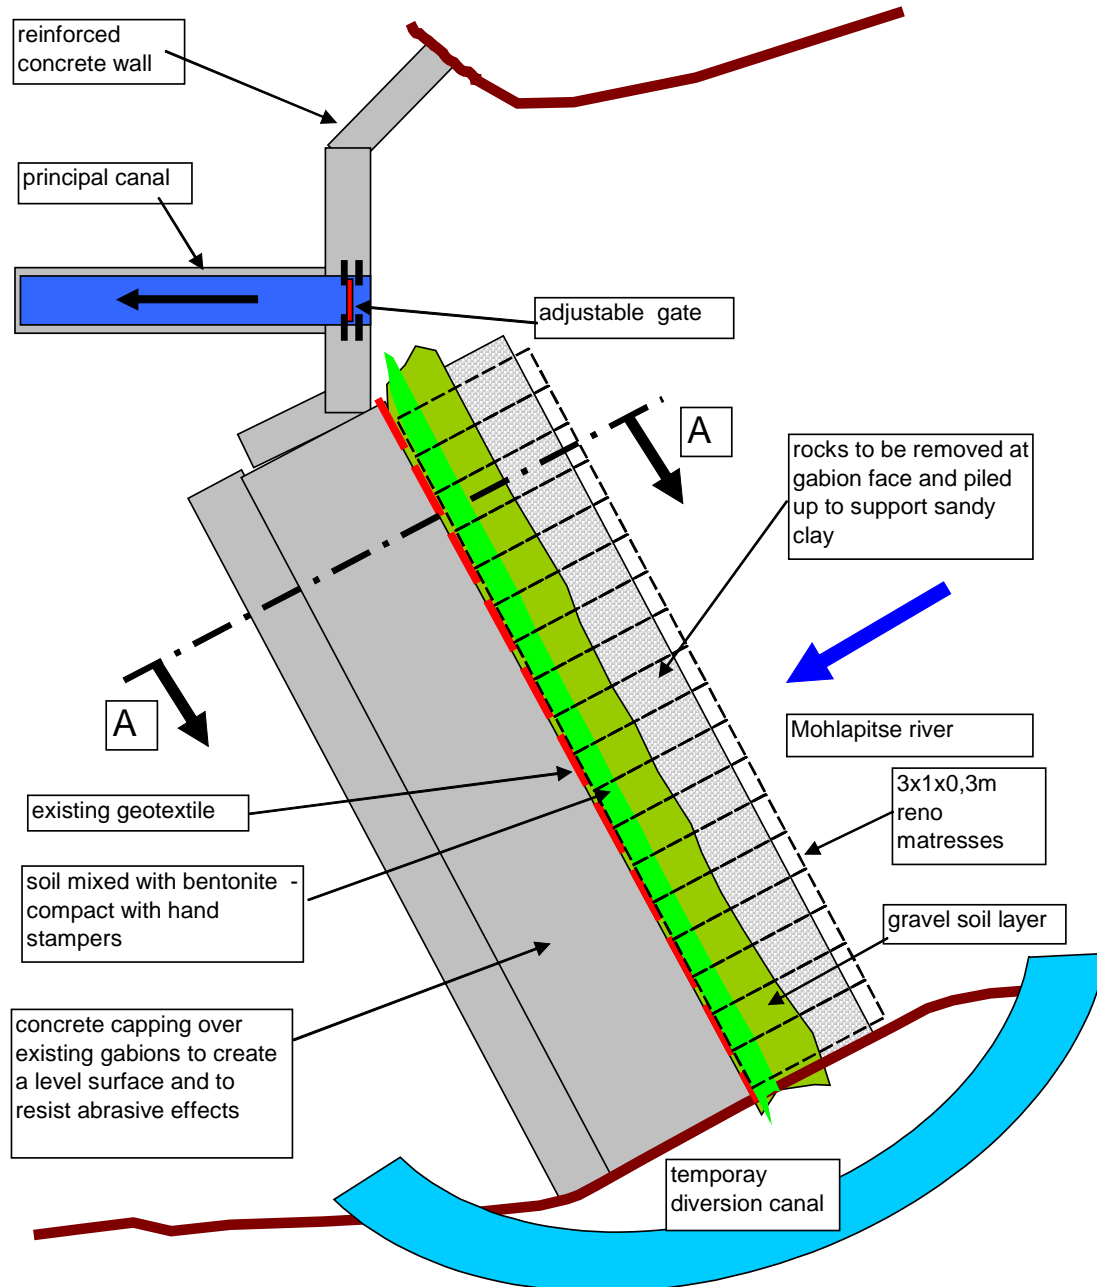
An impermeable weir that raises the level of the water sufficiently to fill the canal should be supplemented with an adjustable gate that allows the inflow into the principal canal to be adjusted as required. A relatively short concrete wall will also be required to house the gate and to close off the space between the right flank of the river and the gabion structure (see figure 6). The completed concrete wall and gate will look similar to that seen in figure 7, with the principal canal leading off as shown. The structure should protrude at least 1m above FSL and thus divert storm waters flows (but not flood waters) back into the river.

**Figure 6** – Schematic plan of weir, showing the canal gate on the right flank of the river

**Cost:** It is estimated that the cost of building an adjustable gate near the right flank of the river, complete with an 8m long concrete wall which has a depth of 1,5 m below FSL and a height of 1m above FSL will be **R 73000 (excl VAT)**. It is recommended that this work be done by a contractor that has experience with shuttering and reinforced concrete. The **contractor** should be able to work without supervision, although it is advisable that his progress be monitored by the ‘turnkey engineer’. It should be possible for him to complete this work in **20 days** – including the time taken to establish a dry working area.

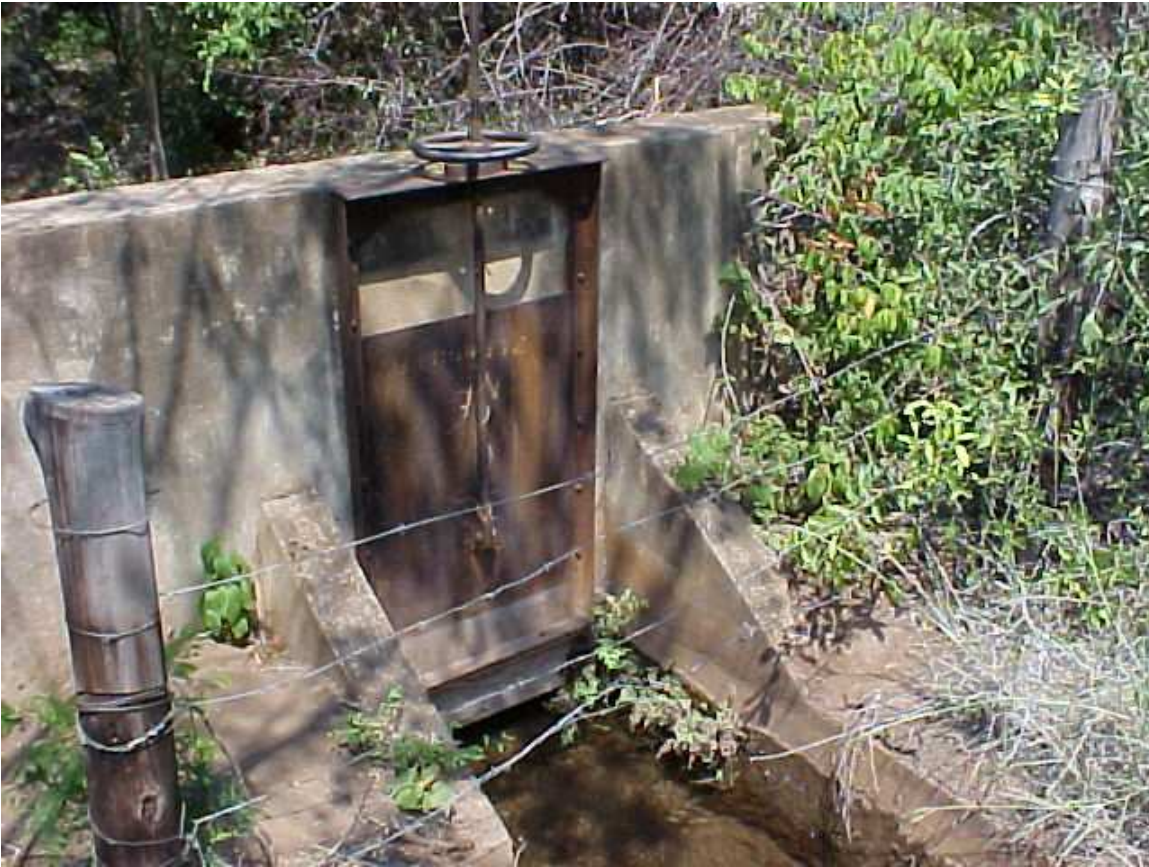
**Figure 7** – Example of an adjustable gate which is able to regulate the water flowing into the principle canal. The gate and all its components should ideally be galvanised.

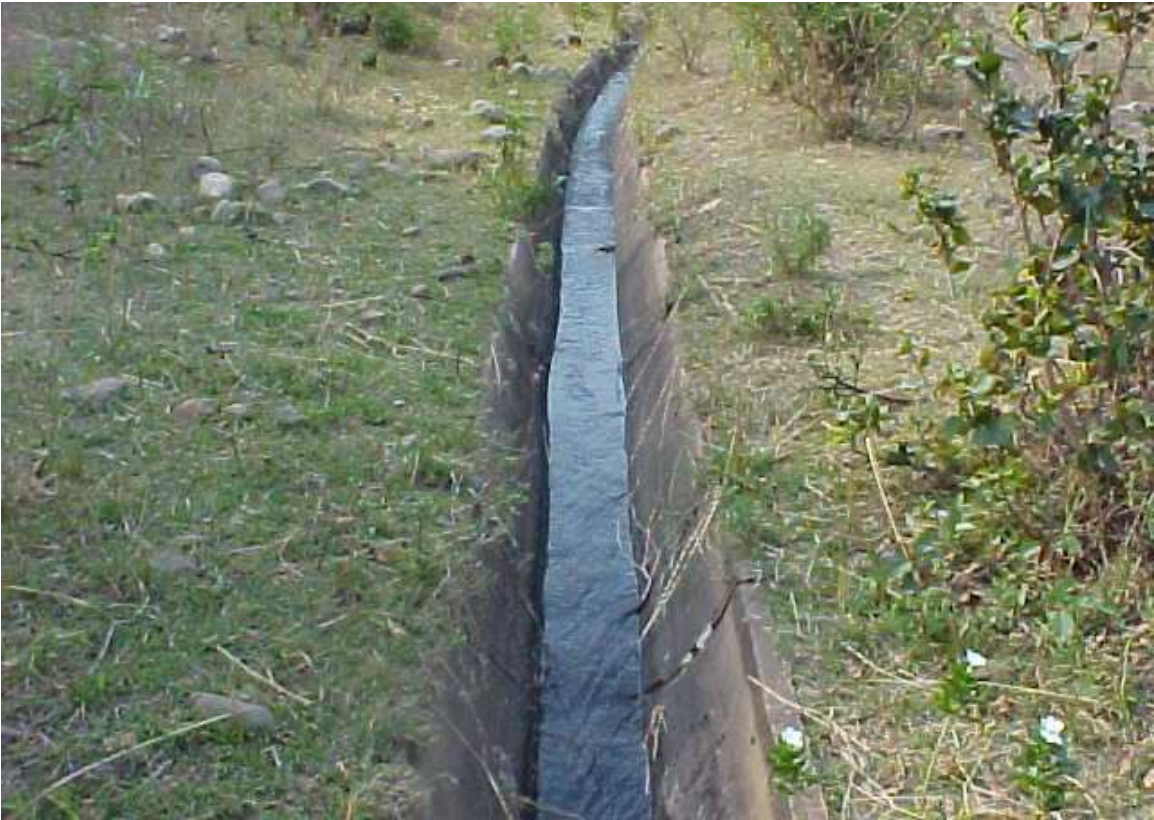
**Figure 8** – View of principal canal

The high losses in the *principal* canal (97litres/sec down to 33 litres per sec) as recorded by Damien do not fit the observed condition of this canal, which appears to be in a good state most of the way. There are however some areas that are obviously causing leakage, notably a section of 50 m at the beginning where the canal was seriously damaged by the floods in 2000. There is also a section of about 100m where there is a buried pipeline that carries the flow. It is possible that ground settlement has occurred here so that the buried pipeline is no longer sealed, accounting for much of the observed losses. If it is confirmed that losses are indeed occurring here, then it is proposed that a surface canal be constructed so that continuity is once again established in the canal. Other than these two areas, totalling to about 150m (to be confirmed), the remainder of the canal does not require reconstruction. This represents about 10% of the length of the principal canal. The writer also inspected the primary canal by running along the length of it to get some feel of its condition (the sun was setting and walking would have meant loss of light before the end of the canal could be reached). A rough estimate of the areas requiring reconstruction would be 5% of its length, 115m. There is also an unlined section at the

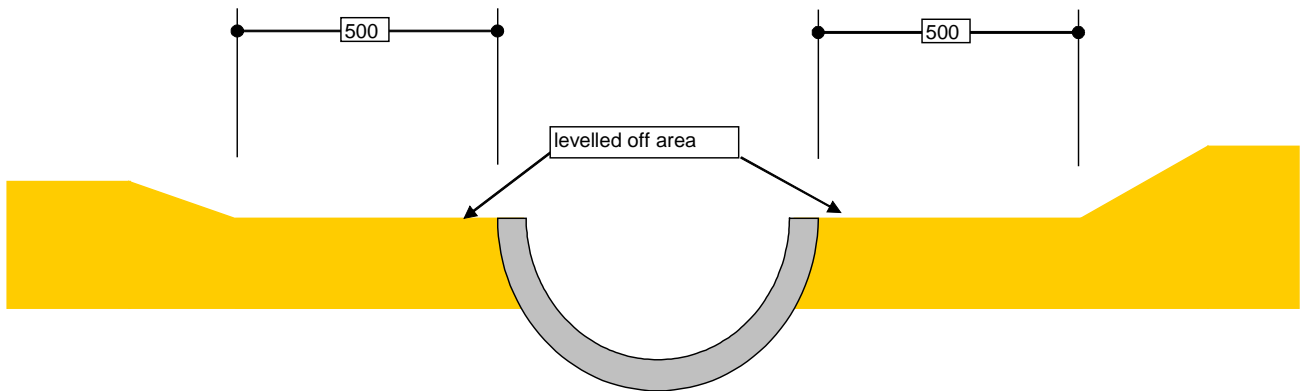
**Figure 10** – proposed detail for clearing of grass and levelling

Whether in preparation for the repair team or whether as a matter of good practice, the canals should be cleaned of all organic matter, as well as the growth 500mm on either side of the canal. Furthermore any build up of ground that may have accumulated next to the canal as a result of cleaning operations in the past should also be removed a distance of 500mm. Having clean and level shoulders next to the canals will significantly reduce the occurrence of ‘wash-in’ when it rains. Such a level area will also encourage people to walk on these ‘path-ways’ and this will help to keep the grass from taking root again. This work can be done by the local community and supervised by a team leader who works alongside the others. Tools will be limited to shovels and a few picks, and after one or two days of on-the-job training, the team is likely to perform very well with only occasional inspection from the project leader required.

**Cost** : From experience that the writer has in work of a similar nature, a distance of R50 wages for 50m is both realistic and achievable. However, Damien has indicated that many of the secondary canals have become buried over the years. Taking this into consideration as well as the fact that most of the secondary canals were unsighted by the author, the production rate should be significantly reduced for the initial budget estimate – say to R50 for 25m, or R2 per m. From table 1 it may be seen that the total length of the various concrete canals is approximately 7400m, and hence the budget for this work would be **R15000**, excluding the cost of the overseeing turnkey engineer. This cost is dealt with separately in **point 6**. A **team of 10** should be able to complete the work in approximately **30 days**.

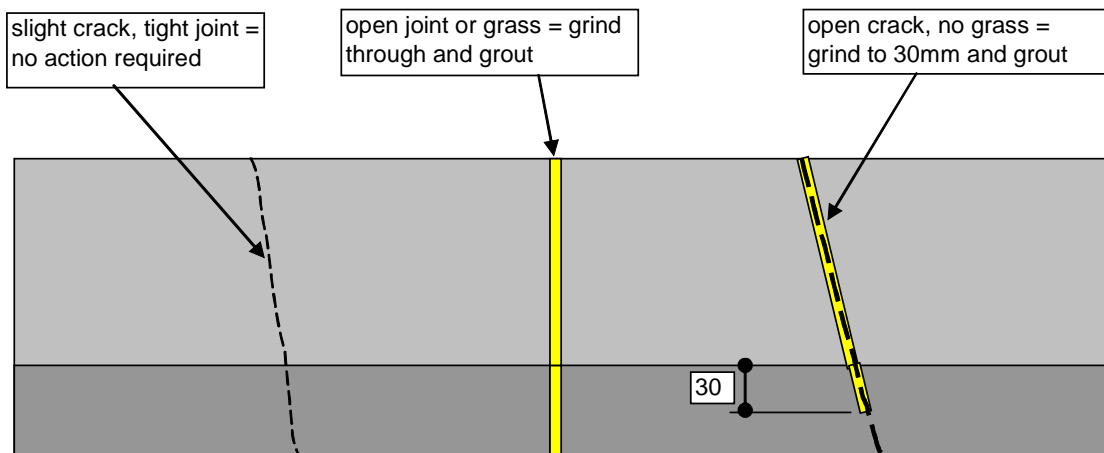
In spite of the joints, cracks do sometimes occur as a result of settlement as a result of poor compaction during construction, and upliftment – which is often induced by vegetation. Also grass may grow into the joints, particularly where the joint is not tight. The sandy conditions of the ground means that any crack or break will result in substantial losses, as has been alluded to earlier.

**Figure 11** – Longitudinal section through a canal showing the possible actions that should be taken to repair cracks and eliminate growth in the joints.

- If a crack is still tight (has not opened) nor affected the shape of the canal, it is recommended that this crack be treated as a joint, and nothing need be done. The crack should seal in the same way that a joint does.
- If the crack has opened slightly, it is recommended that this crack be grooved with a small angle grinder to a depth of 30mm. This groove should then be washed clean of all debris and dust. Later a non shrink grout should be applied taking care to press the grout into the groove as it begins to stiffen. A suitable tool should be used for this so that a degree of pressure can be applied.
- If grass is growing in the joints, then the same procedure as above should be applied, except that the groove should extend right through the joint to ensure that all the growth is cleared away.

**Cost:** For budget purposes it will again be assumed that there is a joint or crack every 2m that requires grinding and grouting (as was assumed for Success) in the secondary canals, and one joint every 4m in the principal and primary canals. It may therefore be calculated that the total repair will cost **R35000**. As with Success this includes the cost of purchasing a 5 kVA generator and two small angle grinders. It also requires 90 diamond tipped cutting discs, petrol, low shrinkage grout, labour, and an assistant supervisor reporting to the ‘turnkey engineer’. The task should take a team of 6 about 40 days.

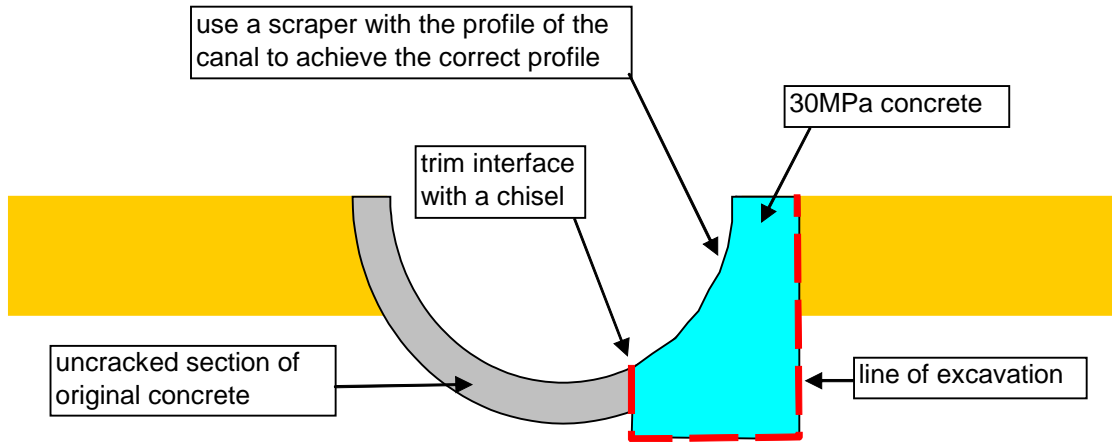
**Figure 13** – The steps involved in making a major repair are indicated

**Proposed Solution :** In the canal in figure 12 the left shoulder of the canal may be seen to be broken up for a stretch of about four meters. When affecting the repair, it is not necessary to break out the whole section as the right shoulder and the base are unbroken. The recommended repair in this case will take the form of figure 13. The broken pieces are taken out with a pick or a chisel and hammer. The unbroken section is trimmed into a reasonably straight line where it will interface with the new concrete. The sides of the excavation should be nearly perpendicular, and the base should extend about 50mm below the base of the old section. The inside profile can generally be achieved by trimming the concrete here with a scraper made from a 3mm plate that has the correct profile. Although a 20MPa concrete has adequate strength, 30 MPa concrete will dissolve much more slowly (calcium, the main ingredient of concrete, leaches out of its surface when it is subject to continuous flows of water, especially where the water is very pure).

**Cost:** From table 1 it may be seen that there are 3550m of secondary canals in the system, and if it is further assumed that there is a major repair required every 25m (to be confirmed) the cost of the 142 repairs has been estimated as **R 26000**. This allows for breaking out the broken concrete, trimming, mixing, materials, placing, trimming and floating. The work should take two teams of three approximately **47 days**. At least one person in the team should be a regular bricklayer or plasterer, and there are a number of these persons in the vicinity.

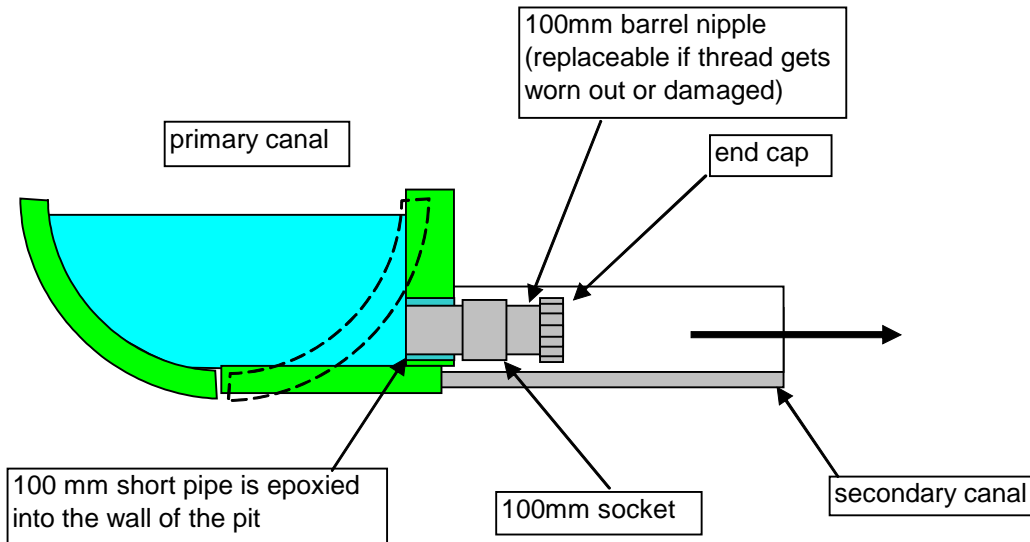
The flow of water into the eight secondary canals is controlled by means of a short 80mm galvanised pipe, that is meant to close by means of a socket and plug arrangement to either allow flow or prevent flow (see figure 16).

**Figure 16** – New ‘gate’ arrangement for supplying water to the secondary canal

**Proposed Solution:** The arrangement shown in figure 9 is considered by the writer as inadequate, and it is proposed that the 80mm pipe be replaced with larger 100mm pipe, which will allow 56% additional water into the canal. This arrangement will create a much better flood condition in the furrow, allowing water to move along the furrow relatively quickly, resulting in uniform soaking along its whole length. Rather than use more water, it will result in the faster and more efficient use of water.

Doing this modification will require the chiselling out of the old pipes and enlarging the hole slightly after which a new 100mm pipe may be epoxied in. (The use of epoxy is recommended to achieve a strong bond between the pipe and old concrete, given that the pipe will be subjected to constant handling/turning motions - the pipe may get loose if it is fastened only with a cement based grout). The proposed new arrangement is shown in figure 16.

**Cost:** It is estimated that it will cost R750 per replacement including labour and supervision, so for 8 pipes, the cost will be **R6000**, on the basis of the turnkey engineer training *one person* to do the work. Total *days* = 6.

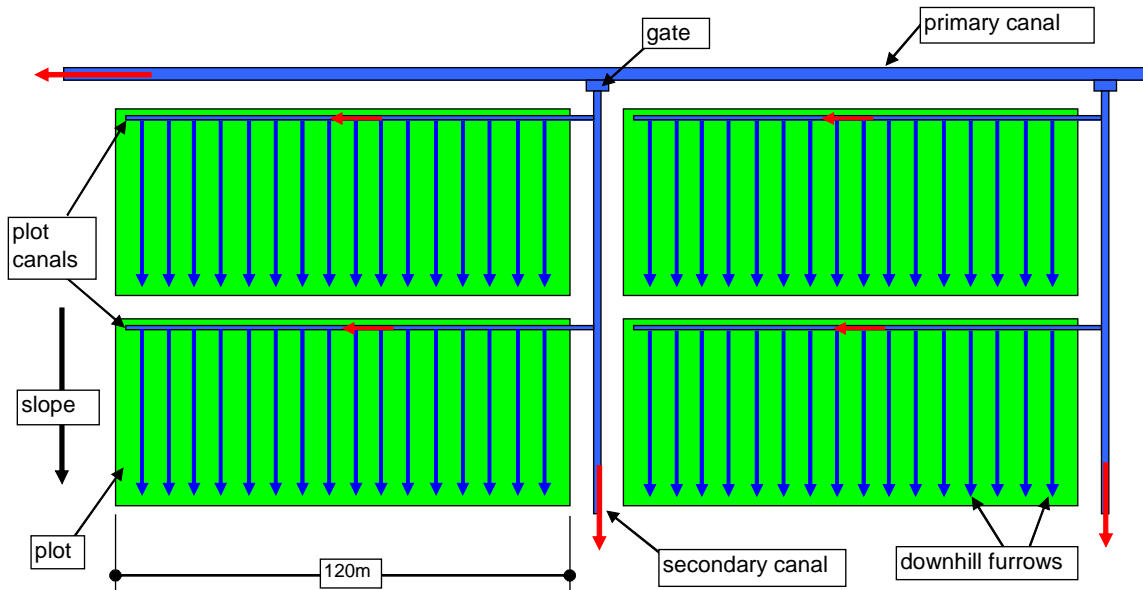
In Damien’s professional opinion (and it must be emphasised that he is a qualified agronomist with a very deep appreciation of the local conditions) the soil at Fertillis is loamy/sandy, which results in rapid soaking of furrow irrigation water. The problem is exacerbated by the fact that the irrigation canals run almost parallel to the contours, at a slight slope. Although this is normal practice, it does not work well in Fertillis as the water soaks into the ground so fast that it takes a long time to reach the other end of the 120m long furrow, and the end result is that an unacceptably low percentage of the land receives water in the allotted time that each farmer has.

**Figure 17** – Plot canals running nearly parallel to contours with furrows running downhill

Damien’s recommendation is that new concrete lined canals, which may be called ‘plot canals’ should be built on the upper contour of each plot so that water may be diverted laterally off the secondary canals into the plot canals and flow the full 120m with minimal seepage. These canals should have regular off takes so that water can be directed into reploughed furrows that now run downhill. The gravity assisted flow will then reach the end of the furrow with a much reduced seepage loss, resulting in a more uniform

**Cost:** Assuming that the average plot is one hectare in area, and that the 96 hectares each have one plot canal of 120m long as indicated in figure 17, the total cost at a cost of R100/m will be R 1152 000. It is advisable that this work be given to a [specialist canal contractor](#), who would employ local labour for the most part. Estimated time is [60 days](#).

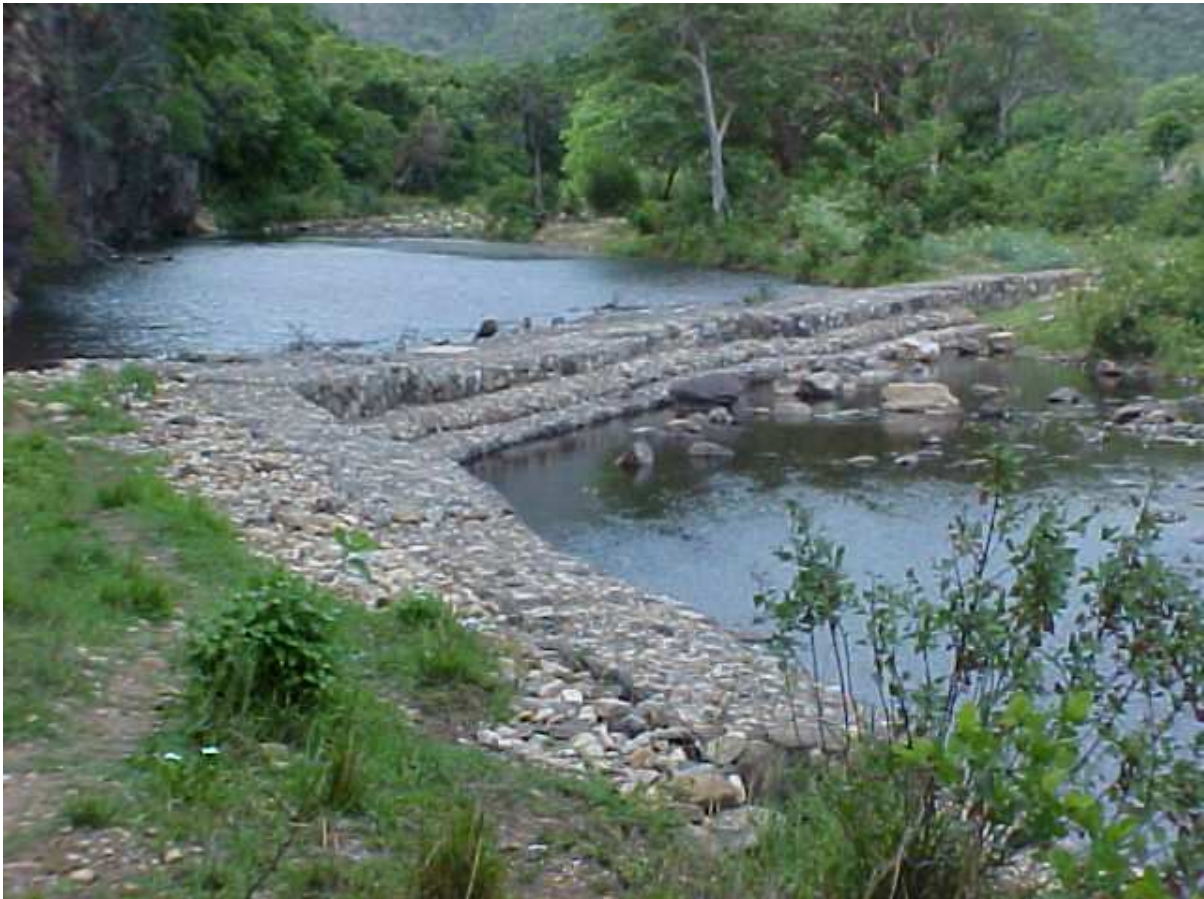
In June/July of 2003 a weir made of gabions was constructed across the river where the old weir had been. In this project the Limpopo Department of Agriculture (LDA) supplied the materials (gabion mattresses) and the community installed them. The structure is shown in figures 1 through 3, and the community leaders are seen in figure 2. While the structure appears to have adequate stability in most places, it also has some serious deficiencies, which may be summarised as follows:

1. Water flows freely through the gabions, and as a result the impounded water does not rise sufficiently for water to be diverted into the canal.
2. There is no means of controlling the amount of water that will go down the canal. Thus the flow in the canal depends solely on the level of the impounded water – which in turn depends on the amount of water coming down the river.
3. There is no flood control barrier at the entrance to the canal to protect it from excessive flows in flood conditions. This has resulted in water undermining the canal (see figure 4).
4. The top of the gabion weir is not level, rising and falling substantially in places. This means that instead of water flowing over it in an even sheet, it will be concentrated in places, thus increasing the probability of damage at these places.

**Figure 1** - Gabion Weir as seen from the west bank - built by community and LDA

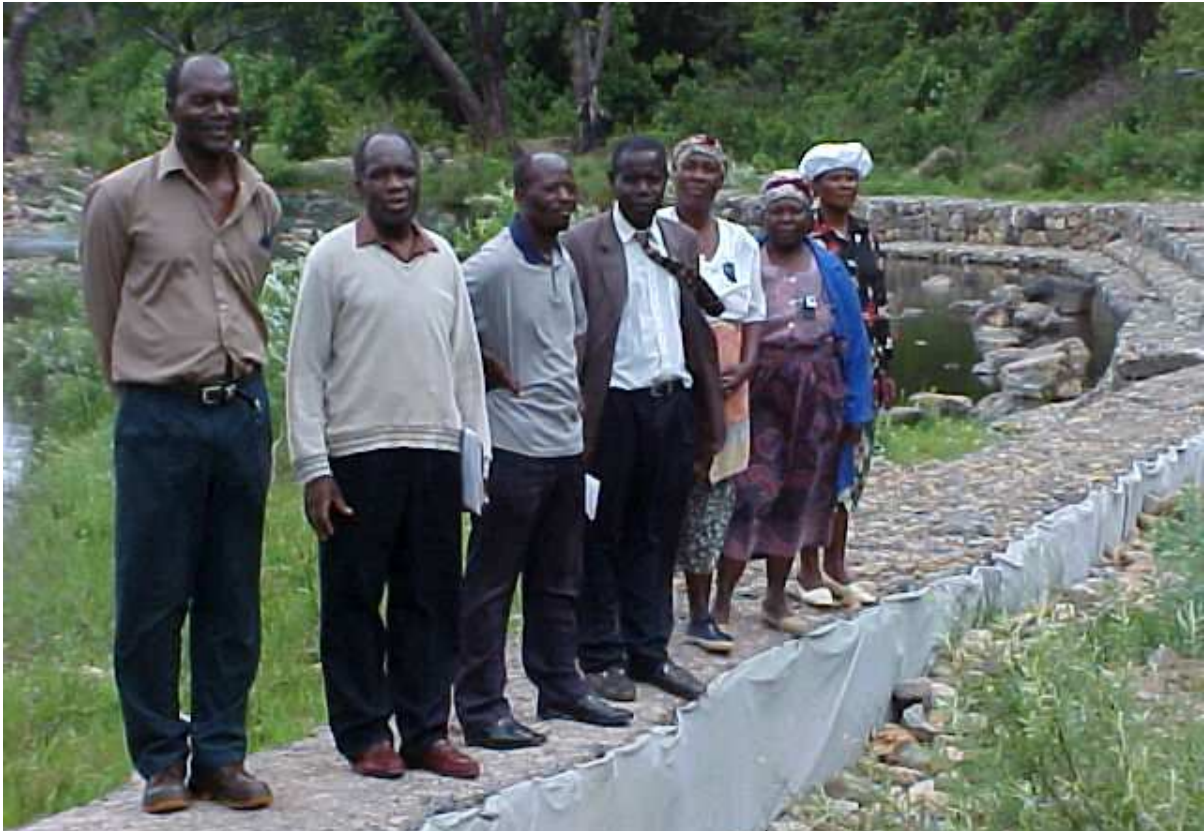
**Figure 2** – Concerned community leaders at Fertillis on 14<sup>th</sup> November, 2003 – notice the geofabric in the foreground

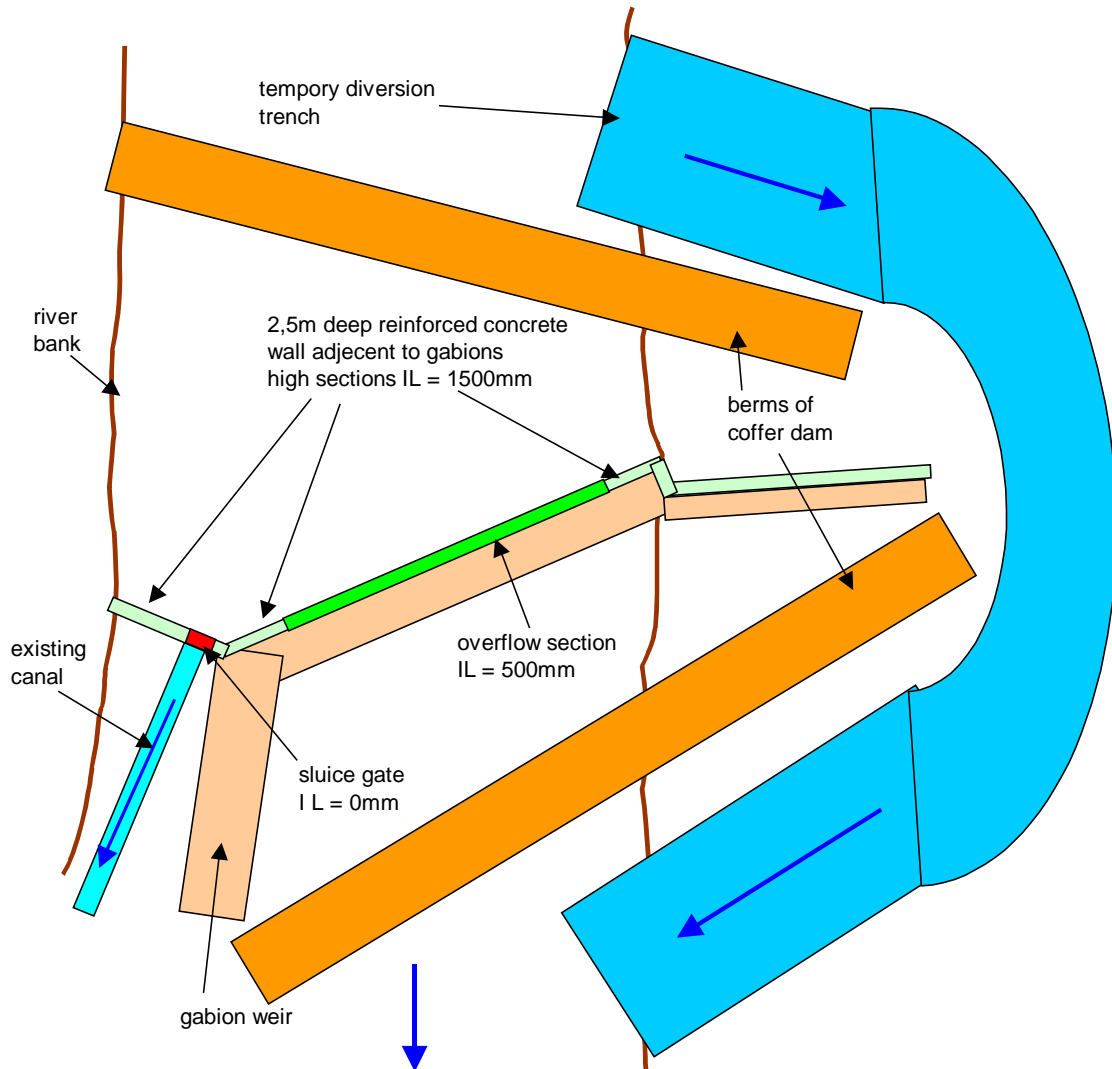
**Figure 5** – General arrangement of proposed diversion weir. A deep RC weir is built directly behind the stable gabion weir, and is higher at the sides. A sluice gate is included. Note the temporary diversion trench, and the berms of the coffer dam.

Figure 5 shows the general arrangement of this solution, while figure 6 gives an example of a correctly designed/constructed diversion weir. Notice that the overflow level of the weir is appropriately higher than the invert level (IL) of the canal, allowing water to flow into the canal. Figure 7 shows the associated sluice-gate in operation. The flow is controlled by means of removable plates - a very simple cost effective arrangement.

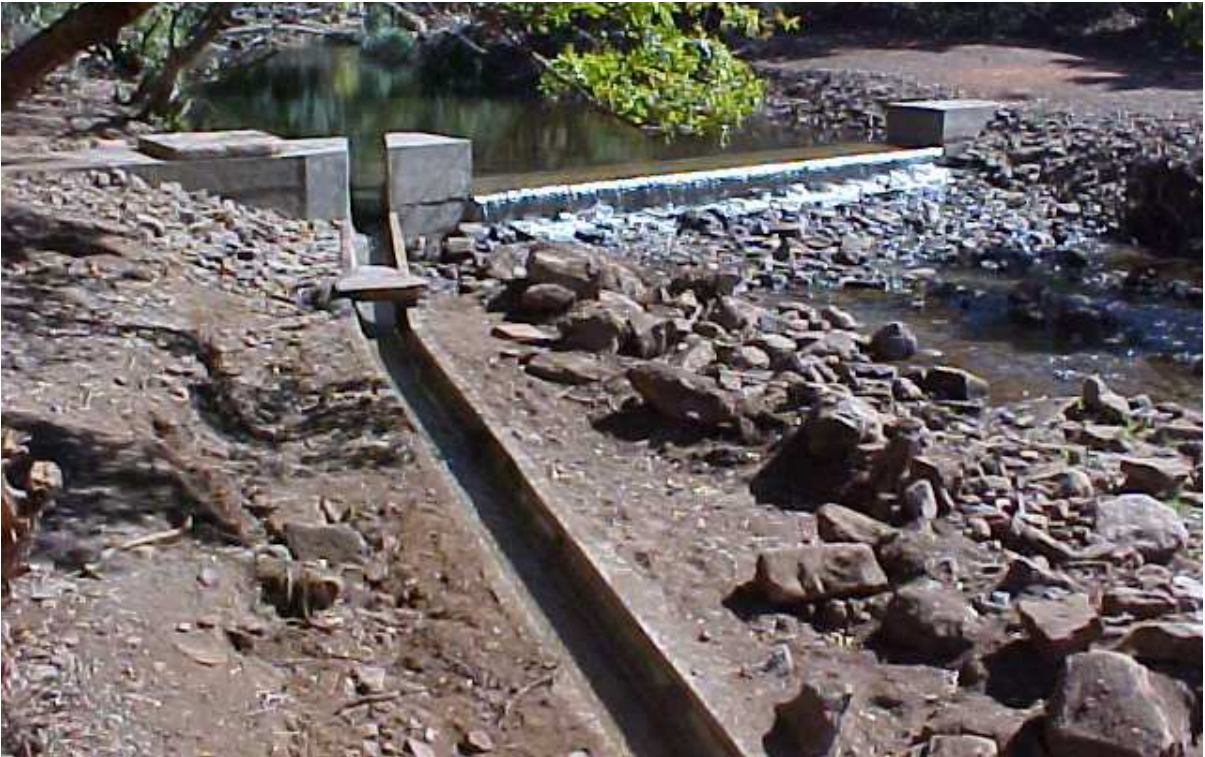
**Figure 6** – The diversion weir and sluice gate off-take at the start of the 7km canal at GaMathabatha (about 40km from Fertillis). The weir and this section of the canal were built by DFA in July 2003 and are additions to an existing 7km canal.

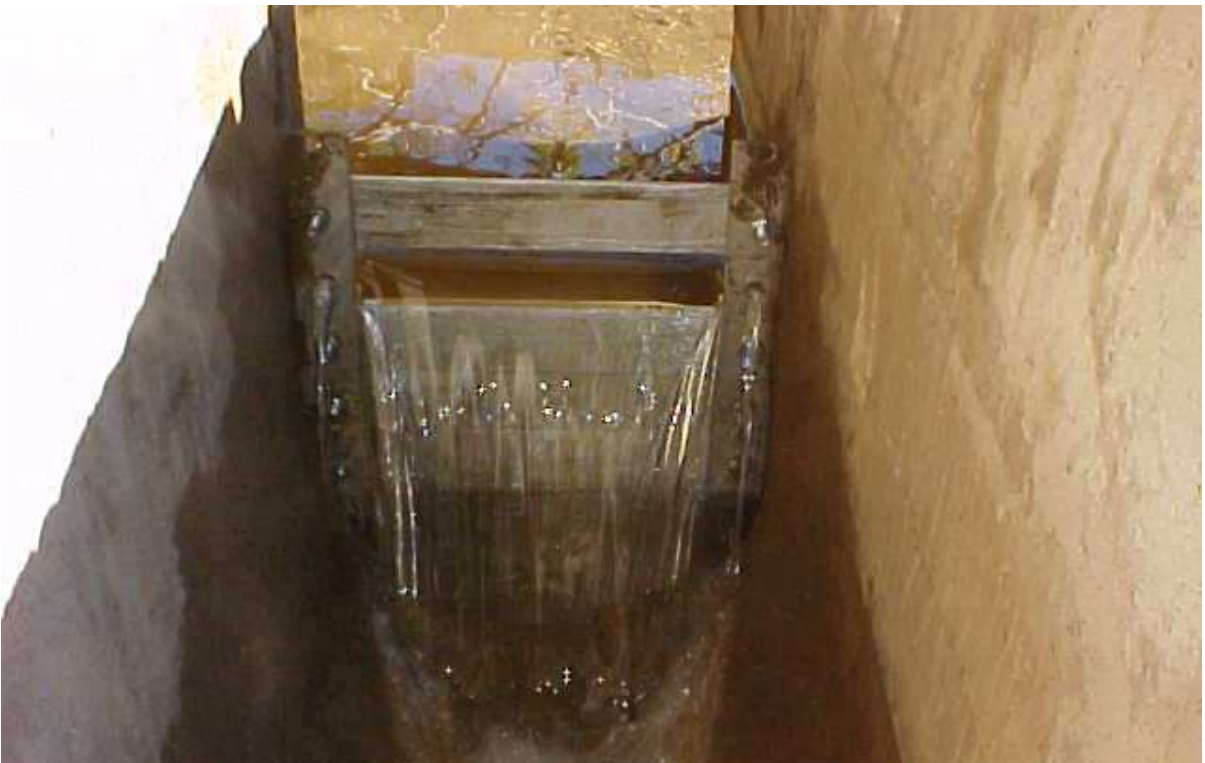
**Figure 7** – A simple sluice gate, made from removable steel plates to allow adjustable flow.
