Chapter 5

Site Testing

5.2 Paving at Westgate

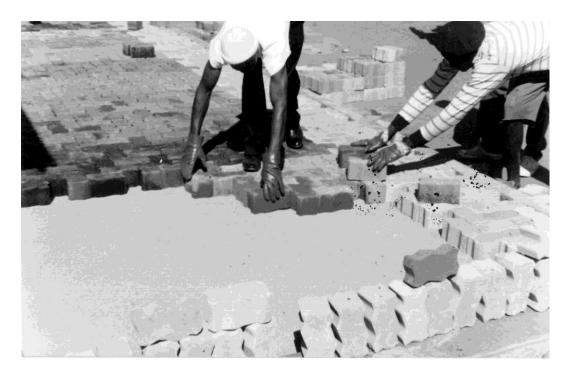
Figure 5.1 Blocks are being installed in a herringbone pattern on a selected 30 mm sand screed in the pedestrian sidewalk

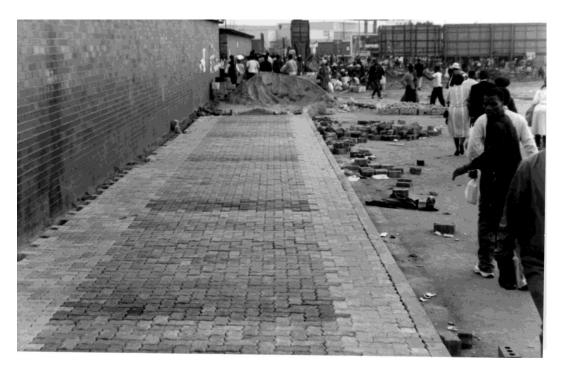
Figure 5.2 Newly completed sidewalk showing the 48 colour-coded mixes

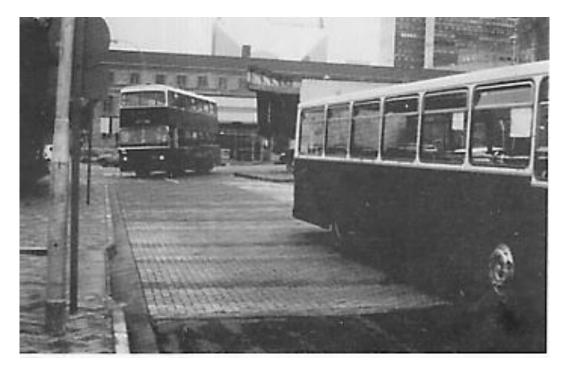
Figure 5.3 (a) The completed road of 100 mm thick paving blocks. Both buses entering and leaving the terminus travel over the blocks.

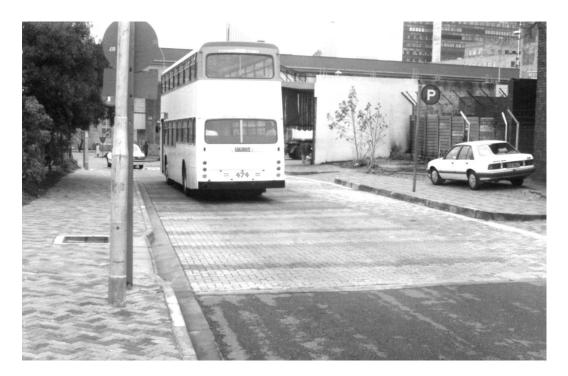
Figure 5.3 (b) The 48 colour coded mixes can be seen.

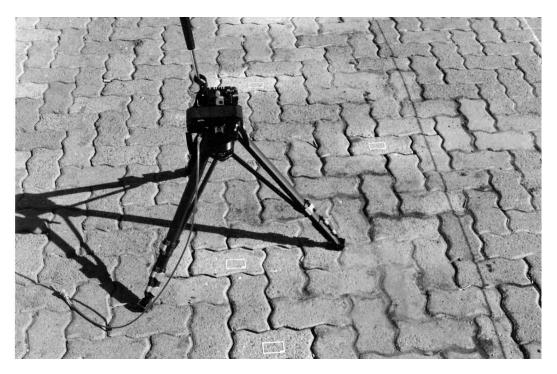
Figure 5.11 View of sidewalk blocks at Westgate, which have been cleaned and prepared for 'after wear' photography.

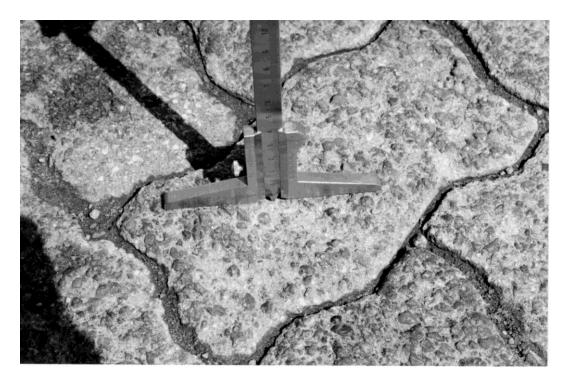
- (a) Apparatus. Figure 5.12 and 5.13 show two possible types of depth gauge. The first type is shown in figure 5.12, and it has a relatively long horizontal 'beam', which is generally preferable, since it is capable of spanning most of the way across the face of the block and establishing the difference between the highest protruding aggregate particle and the trough being measured for depth. This type of gauge is particularly useful in measuring fourth degree abrasion (see chapter 8), where the uppermost surface is often wavelike, or where the protruding aggregate particles may be spaced far apart. The long reach of the 'beam' is capable of spanning the distance between a certain trough and a relatively distant protruding aggregate particle. A disadvantage is that it is awkward to use near the edge of the block, particularly where an adjacent block is at a higher level. Here the smaller depth gauge (see figure 5.13) may be more practical. The lighter and smaller vernier may be used wherever the distance between a trough and an adjacent protruding aggregate particle is small.

Figure 5.12 Depth gauge suitable for measuring severe abrasion.

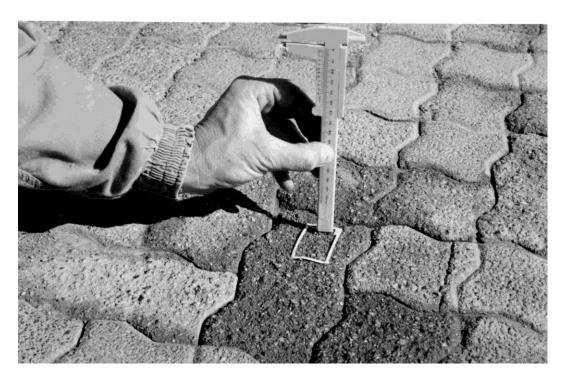
In this investigation the five measurements were all taken within the confines of a 50 mm x 30 mm frame placed on a representative area of the block (see figure 5.13). Taking five measurements in such a confined area reduces the risk of measuring untypical craters. It also makes it possible to identify the position of the craters on the magnified framed area as in appendices Z.2 through Z.196.

Figure 5.13 Depth gauge suitable for measuring normal abrasion.

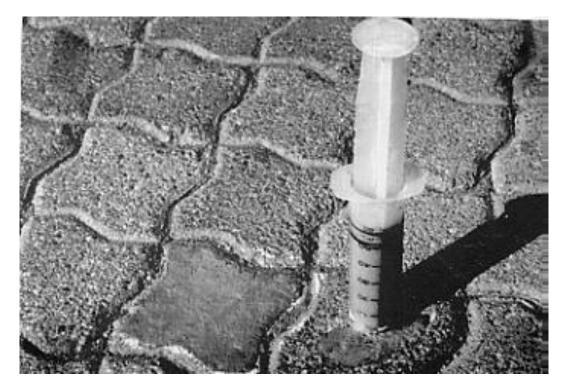
Initially the clay is sucked up into a 60 ml plastic syringe. (The front end must be filed away so that the mouth of the syringe is completely open). If the consistency of the clay is correct, no air bubbles will enter the tube during this process. Next the clay is evenly applied to the surface (see figure 5.14) using small circular movements of the hand, whilst applying even downward pressure on the plunger with the thumb. If correctly done, only minimal finishing with a standard paint scraper or trowel is required.

Figure 5.14 Application of clay to paving blocks using the syringe method

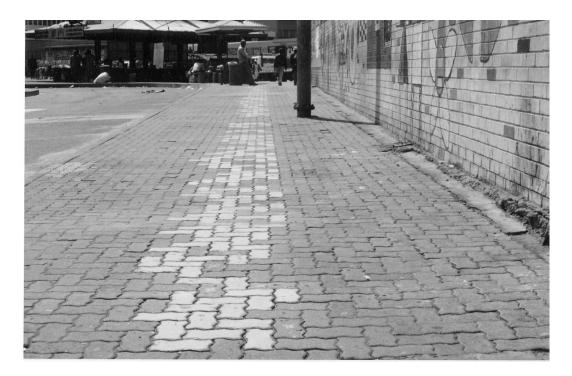
October 1993: The May 93 results had a few anomalies. In order to obtain more meaningful results the two sites at Westgate were remeasured. However this time eight blocks were measured for each mix, and the average mvd recorded in columns F and H of table 14.1. Figure 5.15 shows the sidewalk at the end of this exercise.

Figure 5.15 Application of clay to eight paving blocks in each of the 48 mix designs (October 1993)
